Risk Management Series

Design Guide

for Improving Hospital Safety
in Earthquakes, Floods, and High Winds

FEMA 577 / June 2007

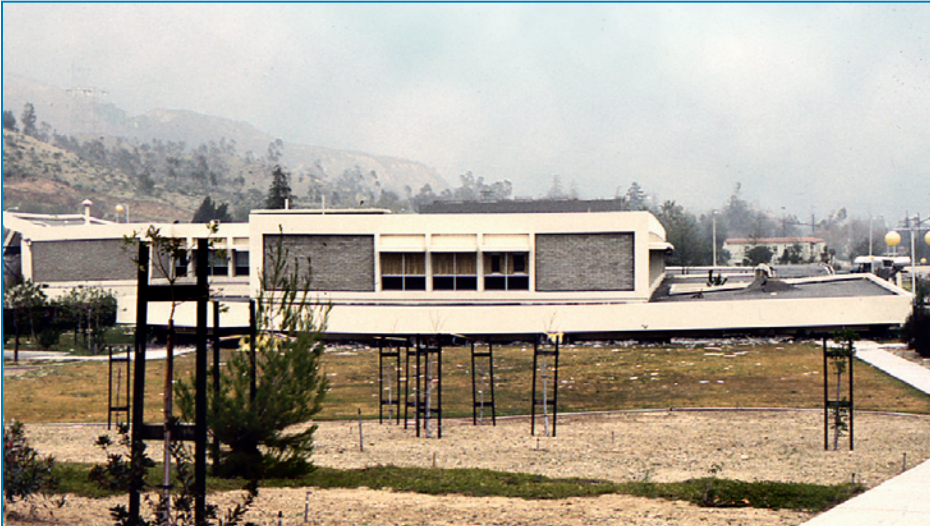
Figure 2-22:
Completely collapsed
first level (not visible)
of Psychiatric Unit

Almost immediately after the event, the patients in the Psychiatric Unit began assembling in a parking lot adjacent to their facility. The need to evacuate was obvious, and the second floor wards were only feet from the ground after the first floor collapse (see Figure 2-22). Controlling and tracking these patients was nearly impossible, particularly in the first few hours. Within 5 hours, evacuation was underway in the main building using interior stairwells. The building had no power and therefore no elevators or lights. The nurses evacuated their own units, ambulatory patients first, and, when sufficient assistance was available, non-ambulatory patients. By that time, a network of ambulances and helicopters had been set up for transfer to other facilities (Arnold, 1983; Lew, 1971; NOAA, 1973).

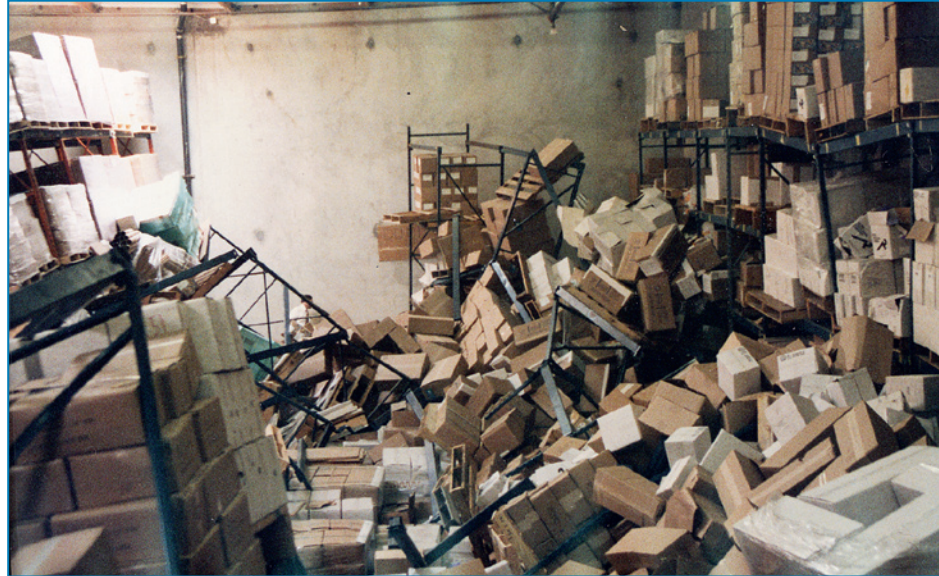
Figure 2-29:
Jumbled contents of a typical office

not well anchored to the structure (see Figure 2-27). Offices and storage rooms, such as the areas used to store critical supplies, medicine, medical records, chemicals, and fuel, can also be severely damaged by shaking (see Figures 2-28, 2-29, and 2-30).

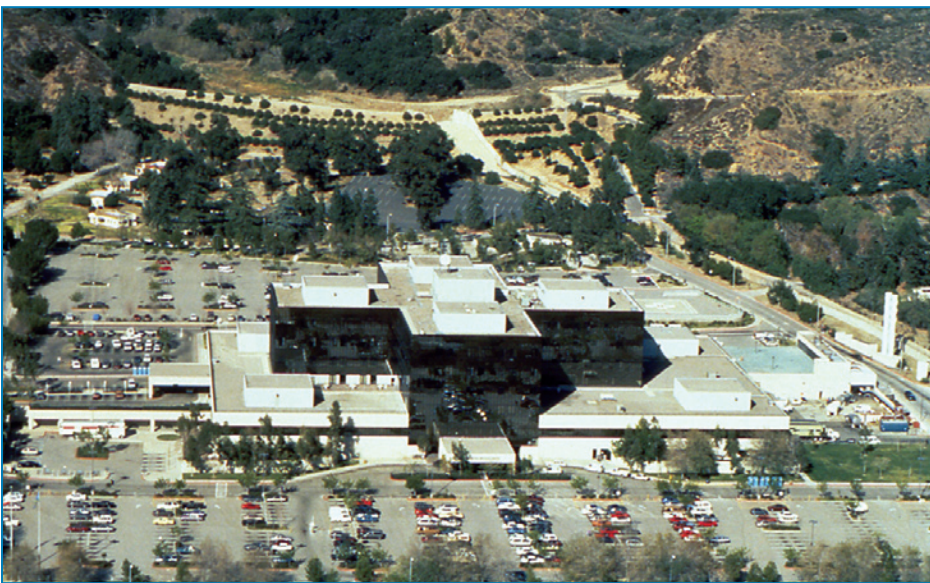
Figure 2-31:
Aerial view of “new”
Olive View Hospital
(1986)

Nearly 15 years after the 1971 earthquake event that destroyed the Olive View Medical Center (see Section 2.3.1.1), a new hospital was opened on the same site in 1986 (see Figure 2-31). Built even stronger than required under the HSSA of 1972, the building has no basement and features a seismic system of concrete shear walls and steel plate shear panels. The building was also equipped with instruments to record its response in future earthquakes.

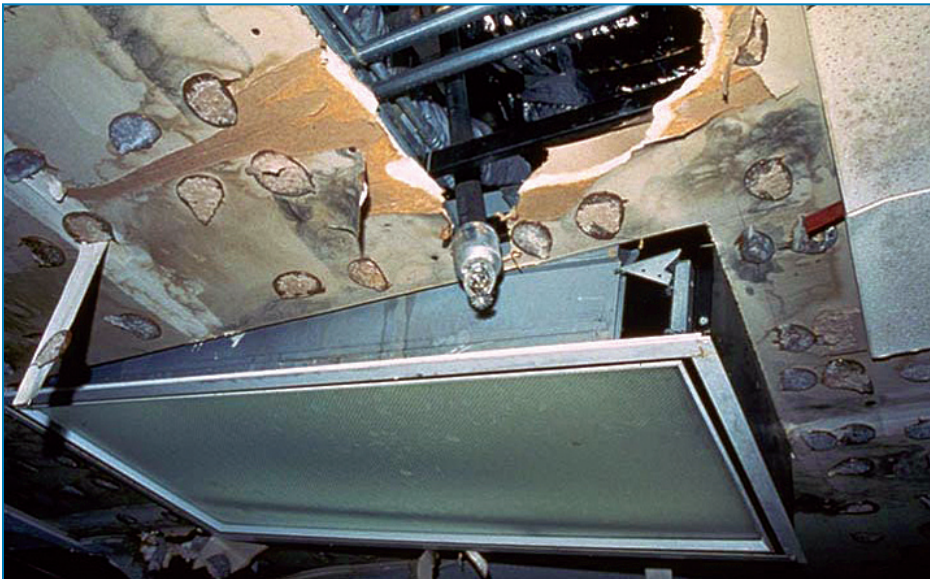
Figure 2-34:
Detail of water damage to ceiling

- Excessive movement and failure of wall-mounted television brackets, causing some television units to fall.
- Extensive damage to suspended panelized ceilings, some exacerbated by leaks from water pipes from above.
- Excessive movement and interaction between gypsum board and other fire-rated ceilings and sprinkler lines, causing additional leaks.
- Movement at the copper tube reheat coils in the ceiling spaces, almost universally at the third through the sixth floor, causing leaks (see Figures 2-33 and 2-34).

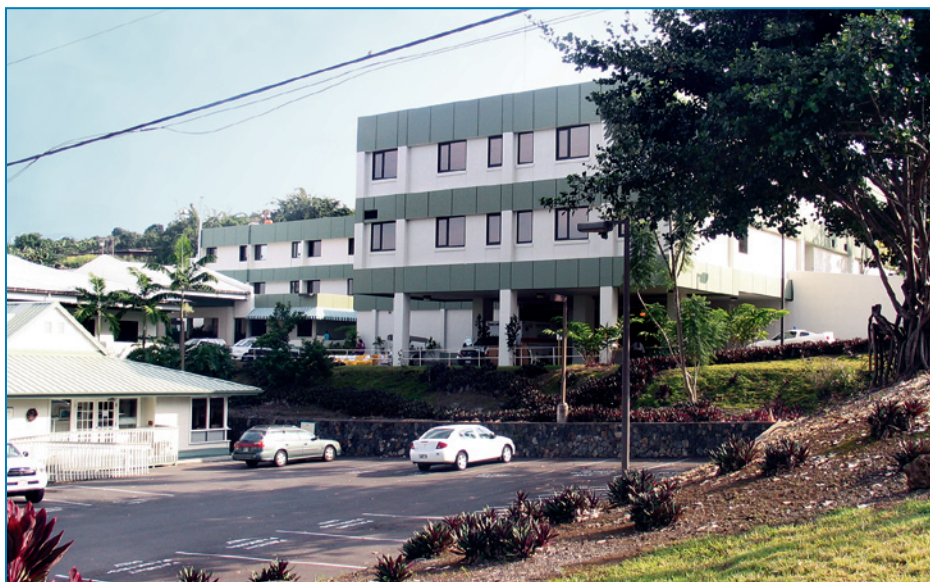
Figure 2-35:
Kona Community Hospital. Addition (1989) supported on isolated columns in the foreground. The original building (1972) is in the left background.

The Special Services Building at KCH (seen in Figure 2-35 behind the small single-story building on the left) contained such an instrument. The response spectrum for one component of motion is shown in Figure 2-36 in blue. Note the rapid decline of spectral acceleration values for very short periods, much less than 0.5 seconds. The orange curve shows a spectral shape that might be expected in association with such high ground accelerations, and is included in building codes. High values of spectral acceleration between the periods of 0.5 seconds and 2.0 seconds, as shown in this standard curve, are usually associated with much greater building damage.

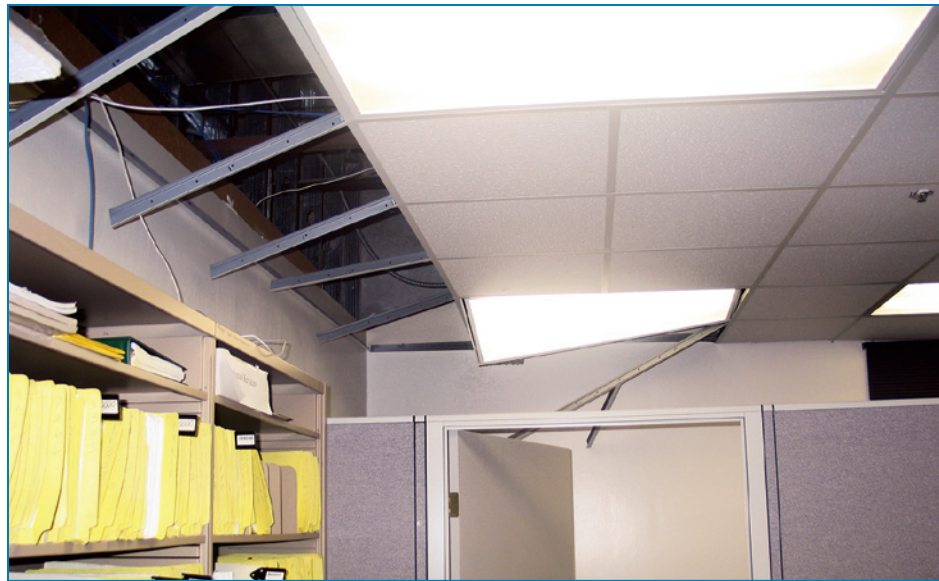
Figure 2-38:

Typical damage at the perimeter of a room from loss of support from the partition-mounted perimeter angles to the ceiling system tees or from contact with the ceiling system and the partitions.

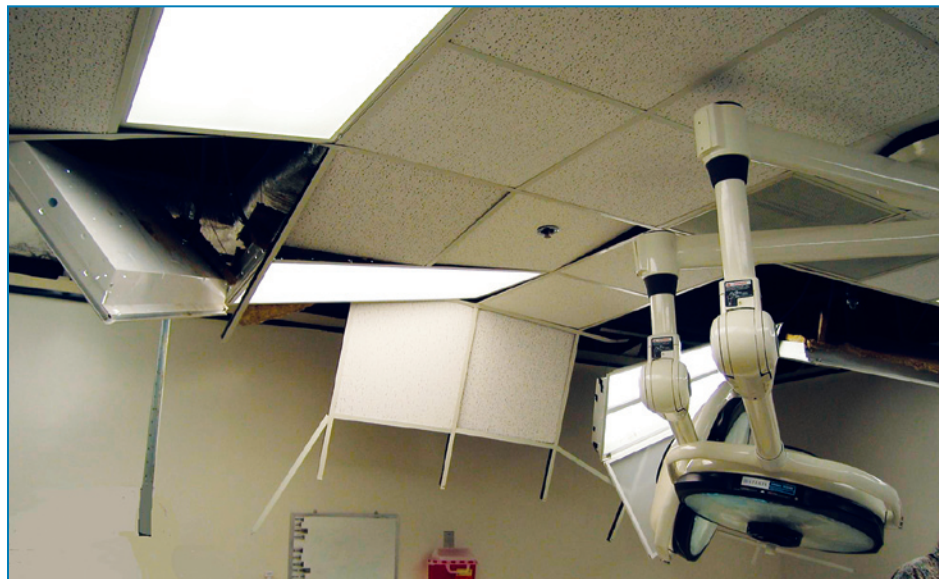
Figure 2-39:

Ceiling damage in the operating room. The round operating lights on the right were not damaged.

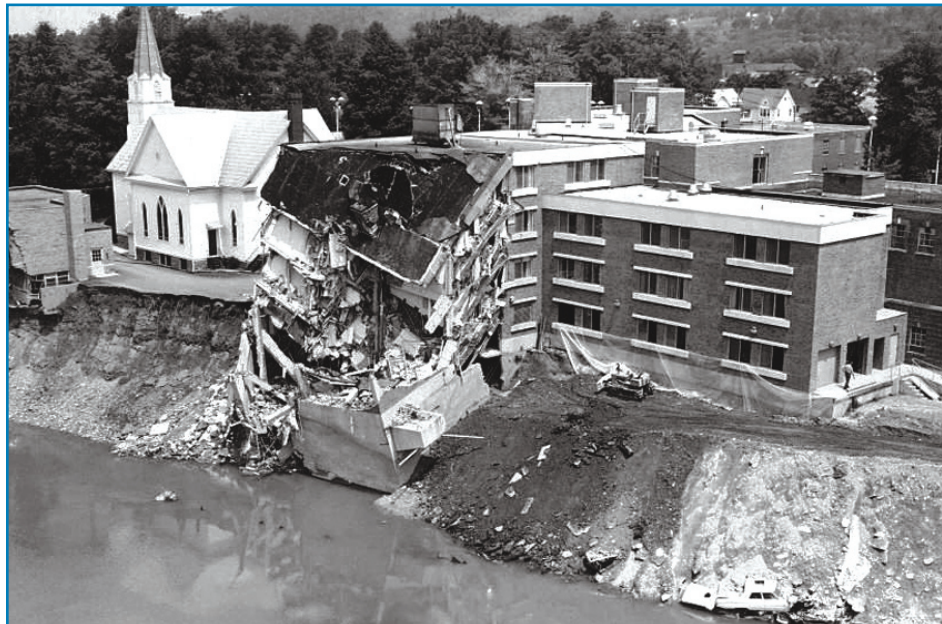
Figure 3-12: Riverbank erosion of the Genesee River during Hurricane Agnes flooding in 1972 eventually led to collapse of this wing of the Jones Memorial Hospital, Wellsville, NY.

Erosion and scour: All parts of a site that are subject to flooding by fast-moving water could experience erosion, and local scour could occur around any permanent obstructions to flow. Graded areas, filled areas, and cut or fill slopes are especially susceptible. Stream and channel bank erosion, and erosion of coastal shorelines, are natural phenomena that may, over time, threaten site improvements and buildings (see Figure 3-12).

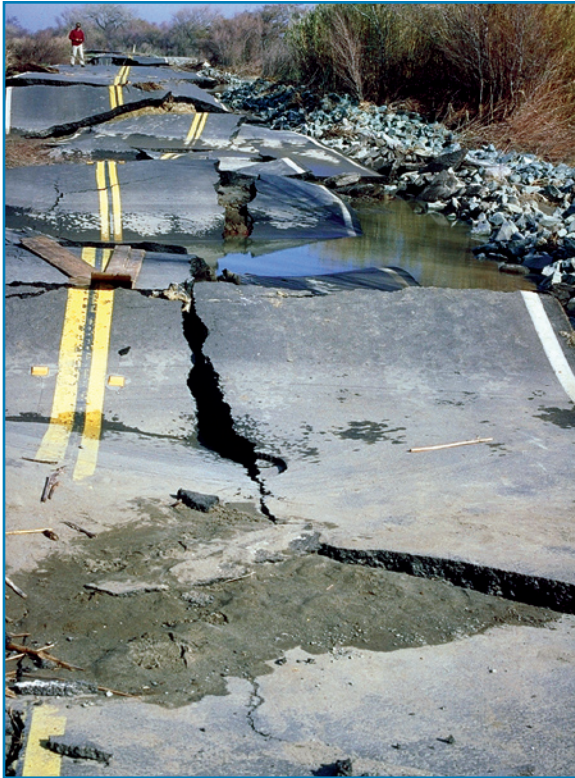
Figure 3-13:

Flooding caused the failure of this road bed.

Access roads: Access roads that extend across flood-prone areas may be damaged by erosion, washout of drainage culverts, failure of fill and bedding materials, and loss of road surface (see Figure 3-13). Road damage could prevent uninterrupted access to a facility and thus impair its functionality.

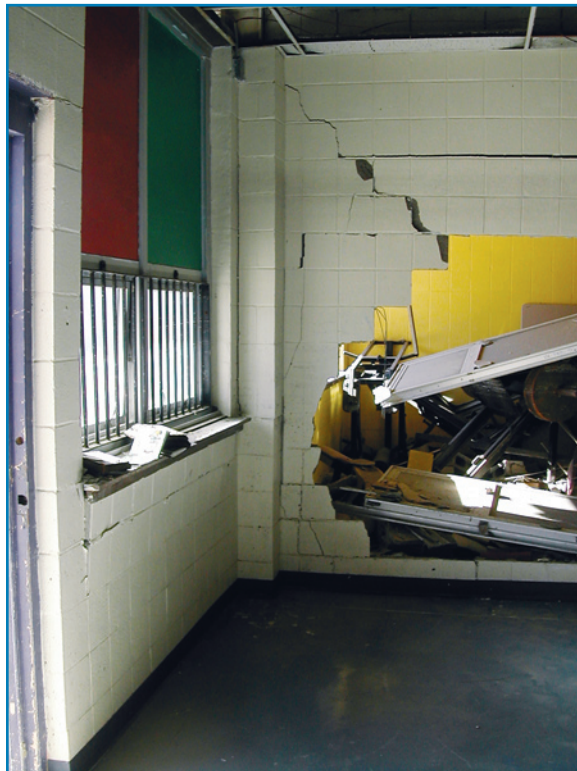
Figure 3-14: Interior unreinforced masonry walls of the Port Sulphur High School in Louisiana were damaged by hydrostatic loads associated with Hurricane Katrina's storm surge (2005).

Depth: The hydrostatic load against a wall or foundation is directly related to the depth of water. Standard stud and siding, or unreinforced brick veneer walls, may collapse under hydrostatic loads associated with relatively shallow water. Reinforced masonry walls perform better than unreinforced masonry walls (see Figure 3-14), although an engineering analysis is required to determine performance. Walls and floors of below-grade areas (basements) are particularly susceptible to damage by buoyancy force. When soils are saturated, pressures against below-grade walls are a function of the total depth of water, including the depth below-grade and the weight of the saturated soils.

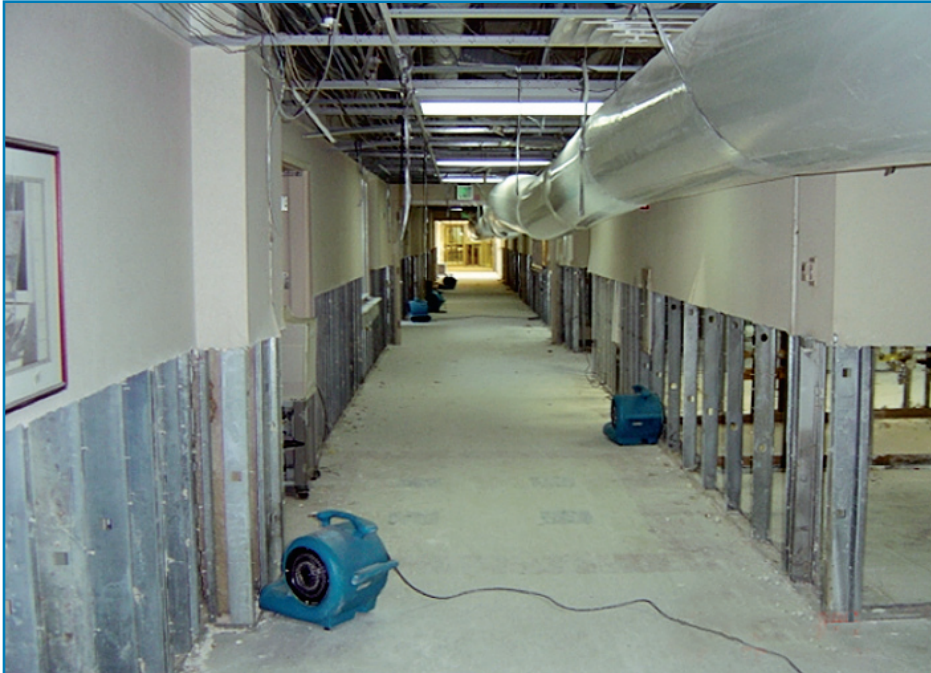
Figure 3-18:
Drying out the ground
floor at Hancock
Medical Center
(Hurricane Katrina,
2005)

taminated with chemicals, petroleum products, and sewage. Under such circumstances, recovery generally involves removal of nonstructural materials and finishes because cleanup and decontamination are expensive and time-consuming (see Figure 3-18). Damage to contents is discussed in Section 3.2.2.6.

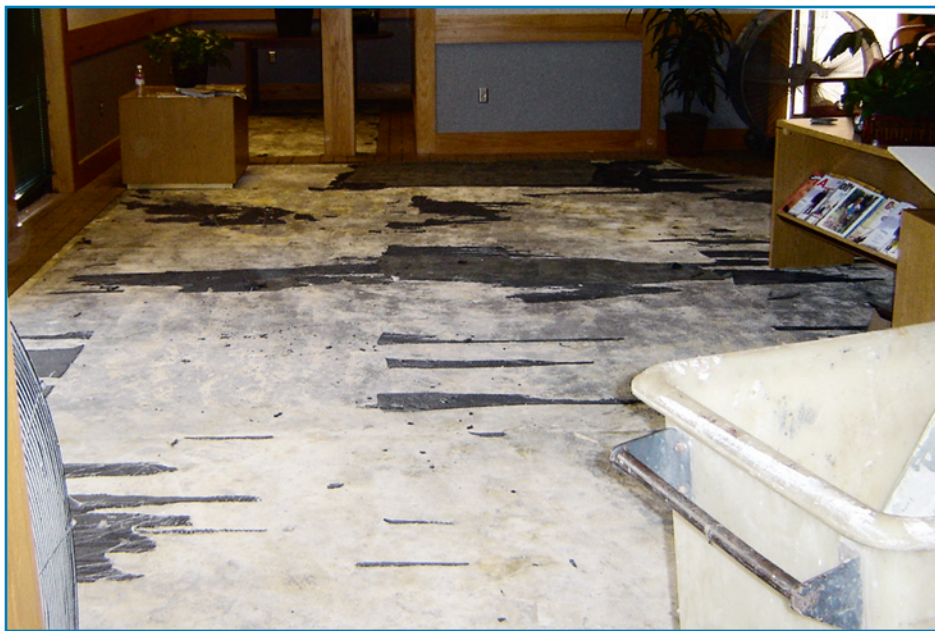
Figure 3-19:
Floor damage at West
Jefferson Medical
Center (Hurricane
Katrina, 2005)

Flooring: Many hospitals have durable floors that resist water damage. Ground floors are often slab-on-grade and finished with tile or sheet products. Flooring adhesives in use since the early 1990s likely are latex-based and tend to break down when saturated (see Figure 3-19). Most carpeting, even the indoor-outdoor kind, is difficult to clean.

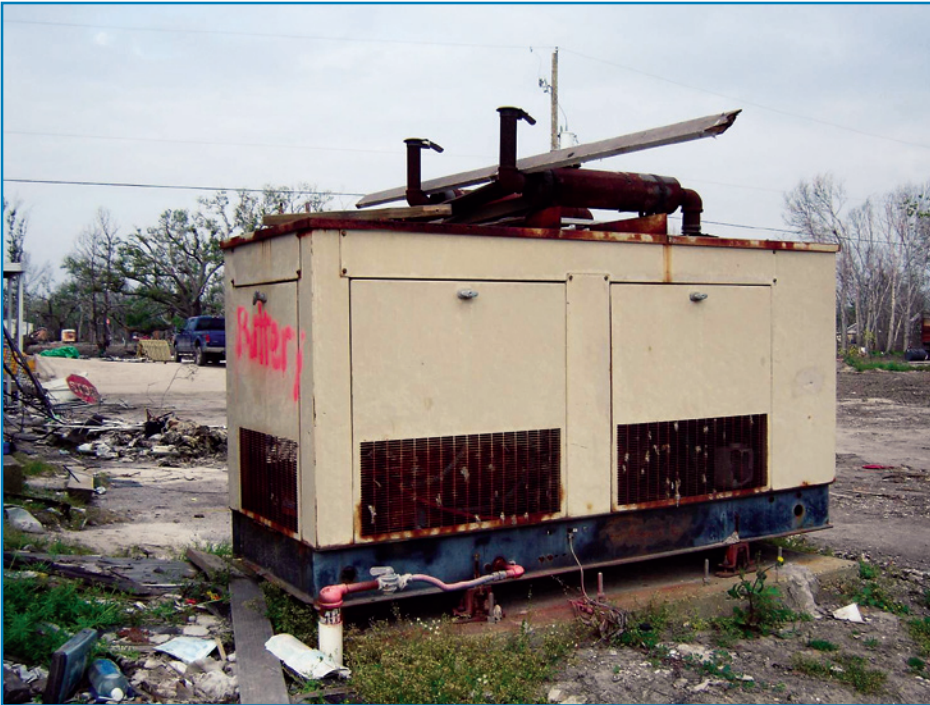
Figure 3-21: Although it was anchored and not displaced by floodwaters, this generator was out of service after being submerged (Hurricane Katrina, 2005).

Emergency power generators: Generators that are installed at-grade are susceptible to inundation and will be out of service after a flood (see Figure 3-21). Even if fuel tanks are located above flood level, truck access for refueling would be impaired if the site is flooded for any length of time.

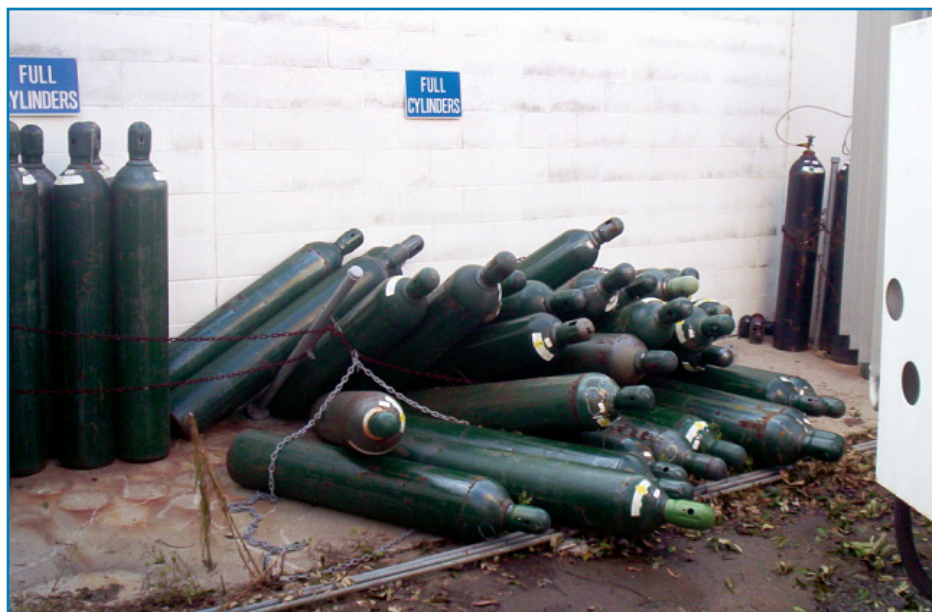
Figure 3-22:

Oxygen tanks stored outside of the Hancock Medical Center were dislodged by flooding (Hurricane Katrina, 2005).

Tanks (aboveground): Permanently installed aboveground storage tanks are subject to buoyant forces and displacement caused by moving water. Standard strapping of propane tanks may be inadequate for the anticipated loads. Tank inlets, fill openings, and vents should be above the DFE, or designed to prevent the inflow of floodwaters or outflow of tank contents during flood conditions. Even temporary storage of tanks can be problematic (see Figure 3-22).

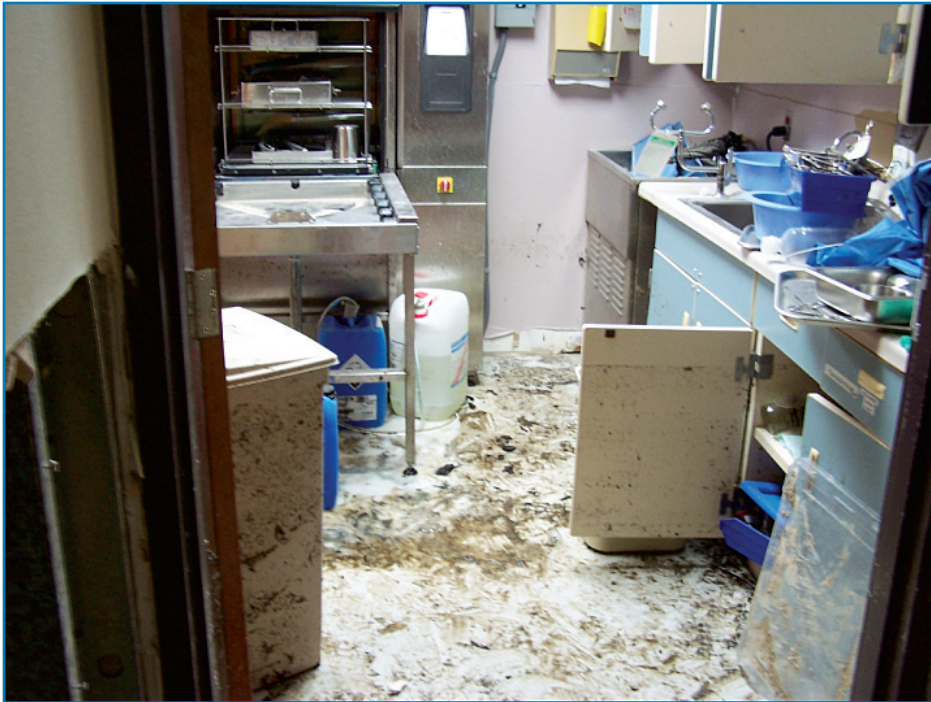
Figure 3-23: The interior of the Hancock Medical Center required extensive cleanup following flooding (Hurricane Katrina, 2005).

rosion, and typically is discarded (see Figure 3-23). Some wood furniture may be recoverable after brief inundation.

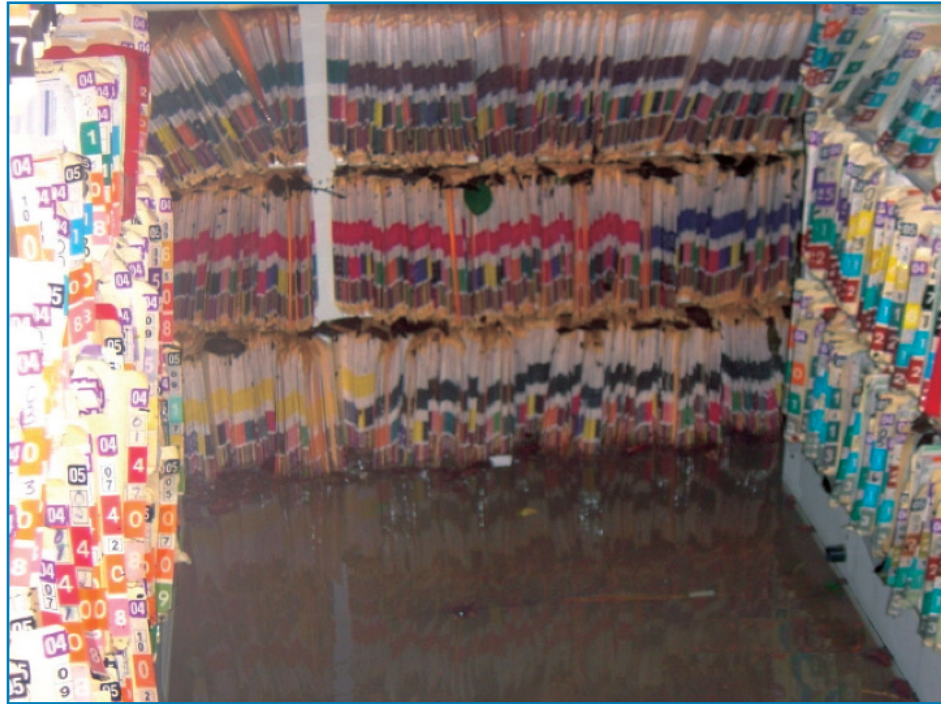
Figure 3-24: Medical records saturated by floodwaters (Hurricane Katrina, 2005)

Medical records and office files: Valuable records may be lost if flooded. Although expensive, some recovery of computerized and paper records may be possible with special procedures (see Figure 3-24).

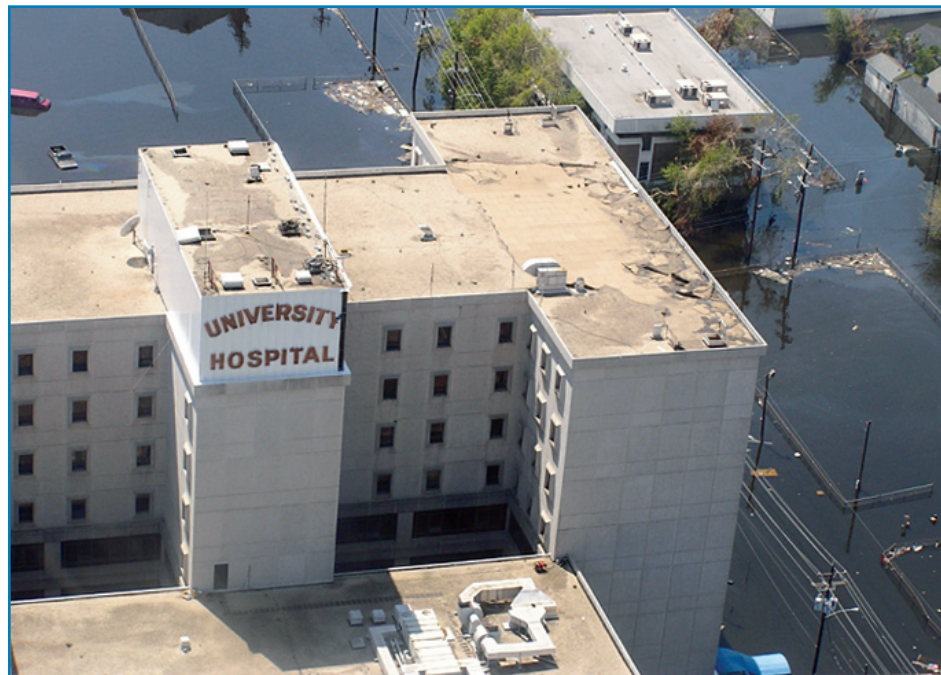
Figure 3-25:
Hurricane Katrina's floodwaters surrounded most hospitals in New Orleans, complicating access for evacuation, as well as limiting treatment options for residents.

Many decisions made with respect to hospitals are, in part, based on a determination of acceptable risk. Risk includes the potential losses associated with a hazard. Ideally, risks can be defined in terms of expected probability and frequency of the hazard occurring, the people and property exposed, and the potential consequences. Choosing a site that is affected by flooding is a decision to accept some degree of risk. Although the flood-prone land may have a lower initial cost, the incremental costs of construction, plus the likely increased costs of maintenance, repair, and replacement, may be significant. Another cost of locating a hospital in a flood-prone area is related to access problems if streets and access roads are impassable. The building may be elevated and protected, but if access is restricted periodically, then the use of the facility is affected (see Figure 3-25).

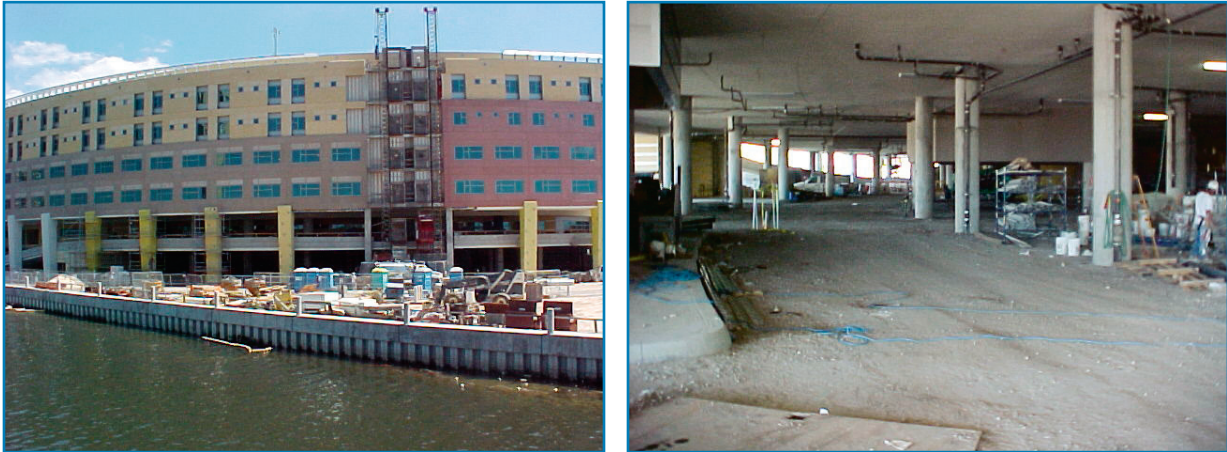
Figure 3-29: Tampa General Hospital had its new Emergency Department wing designed to be elevated on columns, well above hurricane storm surge flooding elevations.

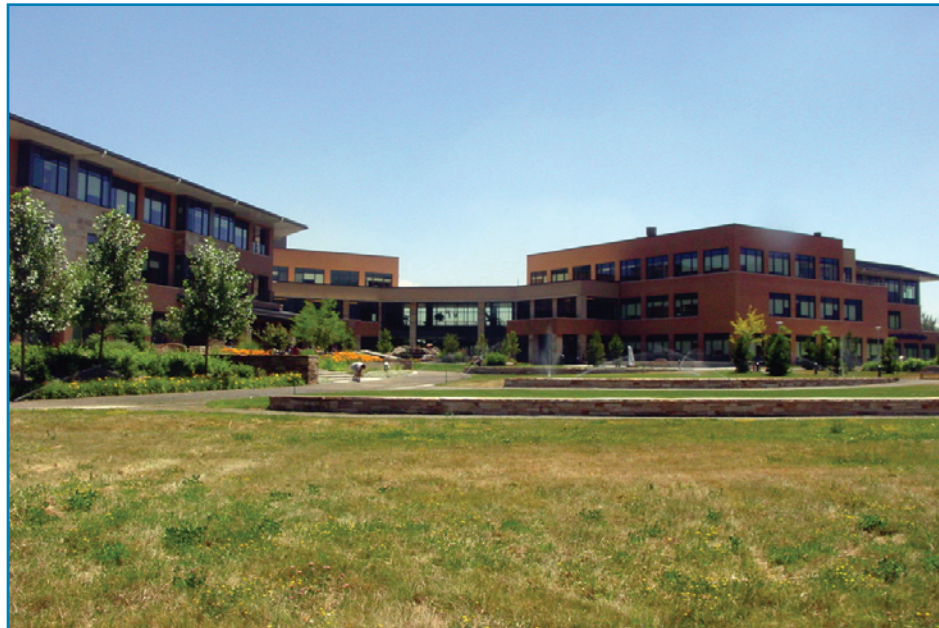
Figure 3-32:
Boulder Community Foothills Hospital main entrance, with landscaping and retaining walls for portion of site filled to the 500-year flood elevation (Boulder Creek is behind photographer).

The 17 acres of the site that were needed for the campus, entirely outside of the designated floodway, were proposed to be filled to an elevation of one-foot above the 100-year flood elevation. The remaining 22 acres were placed in conservation easement. Engineering analyses were performed to demonstrate that no increase in flood elevations would result. The city required approval of a Conditional Letter of Map Revision from FEMA prior to approving the plans. The fill was required to be compacted to 95 percent of the maximum density obtainable with the Standard Proctor Test method. The earthen fill is gently sloped to natural grade and various landscaping elements and retaining walls provide a pleasing transition (Figure 3-32).

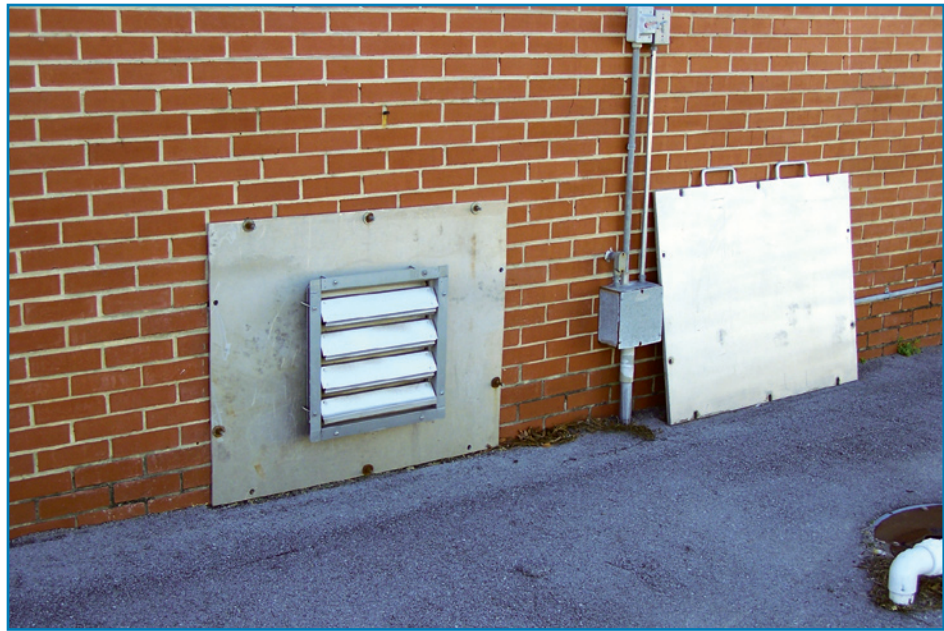
Figure 3-44:
The ventilation openings for the original building's crawlspace are protected with floodproofing panels that are bolted in place when flooding is predicted.

The frames that hold the floodproofing panels are permanently-mounted and sealed against the building to prevent seepage. The frames are designed with an aluminum cover to keep the channels free of dirt and debris. The metal panels that fit into the channels have rubber gaskets that are inspected each year as part of the hospital's routine maintenance program. The manufacturer recently advised replacement of the gaskets, as the 10-year anniversary of installation nears.

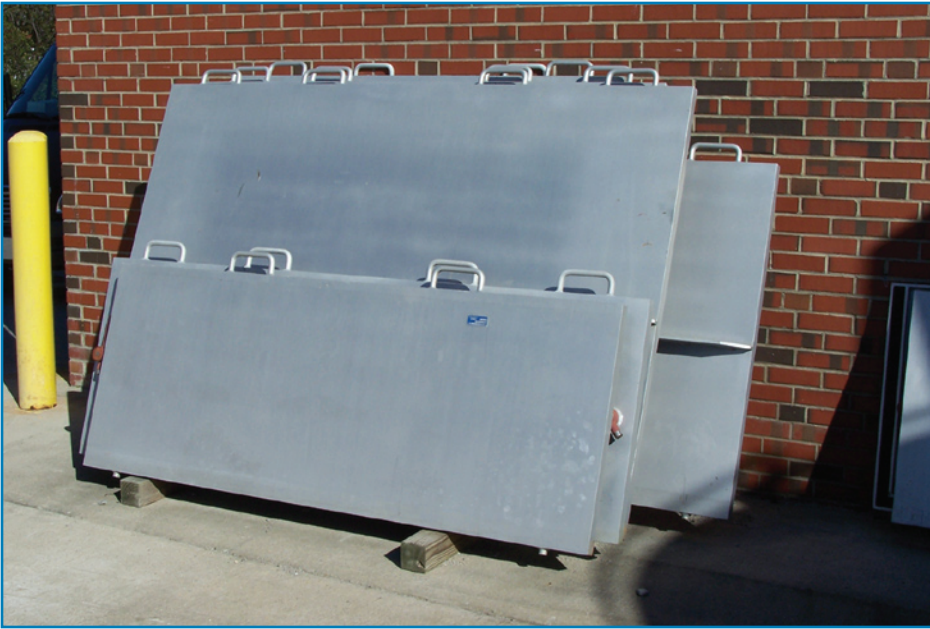
Figure 3-45:
Large floodproofing panels are stored at the hospital, ready for installation when coastal flooding is predicted.

A total of 15 panels of different sizes are stored onsite (Figure 3-45). Although the panels can be handled by two people (Figure 3-46), the hospital has an on-call agreement with a local rental company to use a forklift to facilitate moving them into place. All panels can be installed in about 3 hours.

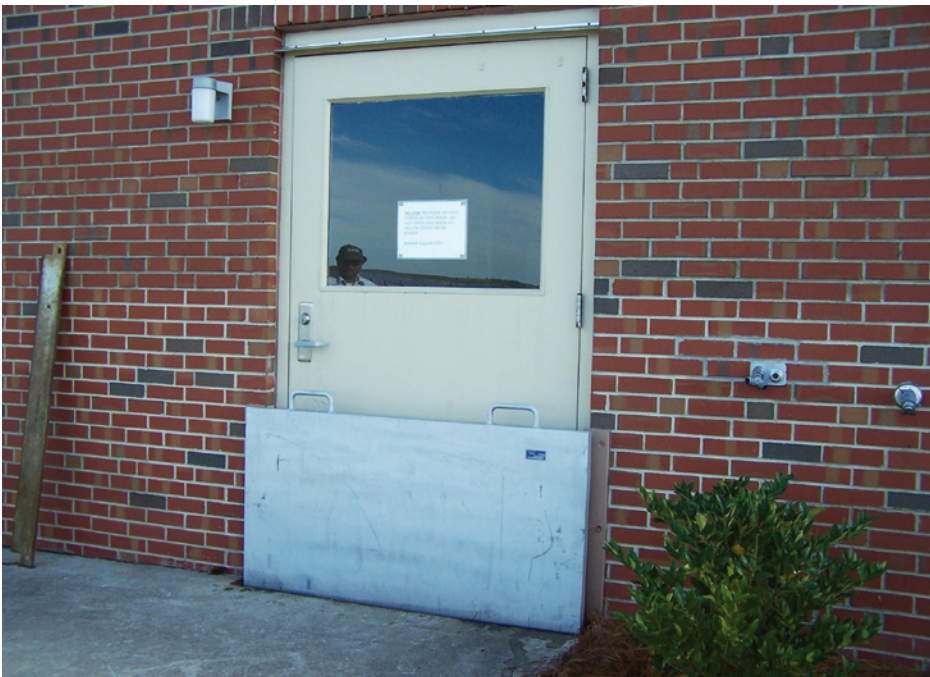
Figure 3-46:
Most of the panels can be installed by hand. Note the protective metal strip leaning against the building on the left; normally this strip covers the horizontal channel into which the panel is inserted.

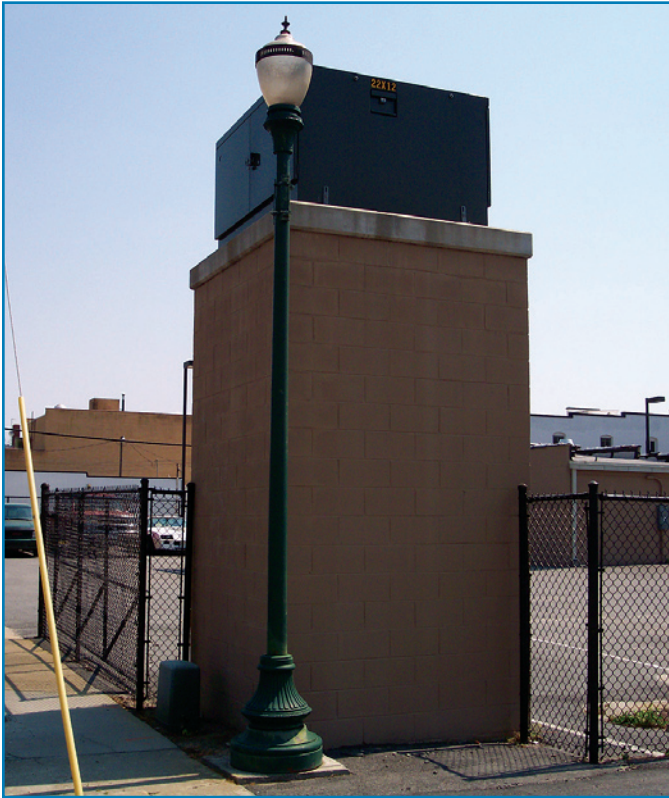
Figure 3-48:
Elevated utility box

Elevate components: Whether located inside or outside of the building, some components of utility systems can be elevated-in-place on platforms, including electric transformers, communication switch boxes, water heaters, air-conditioning compressors, generators, furnaces, boilers, and heat pumps (see Figure 3-48).

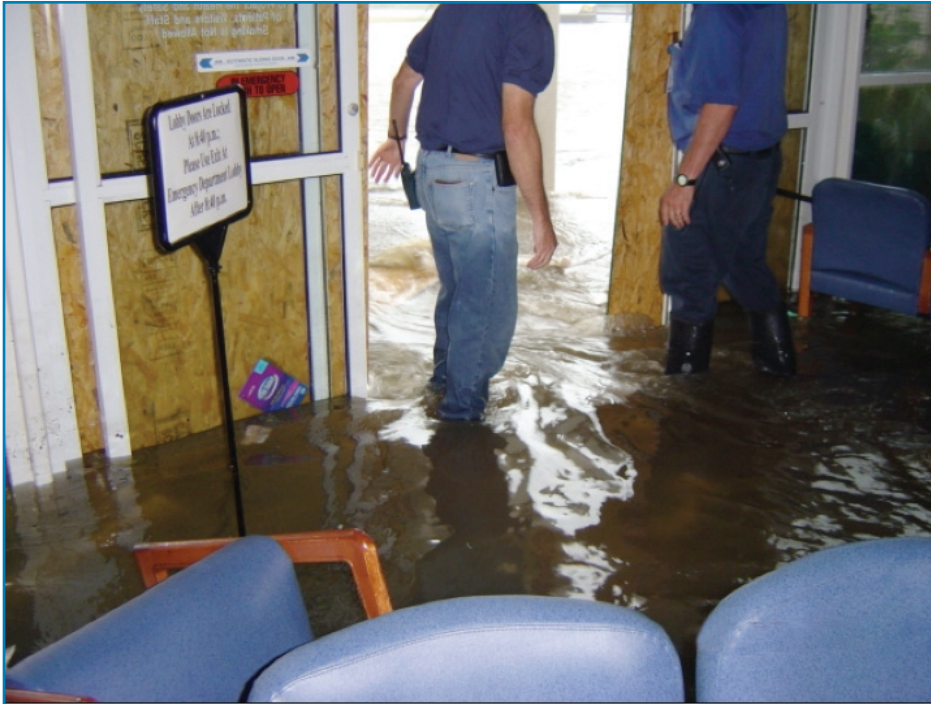
Figure 3-49:
Flooding at Hancock
Medical Center during
Hurricane Katrina

Panels for doors: For shallow and short-duration flooding, panels of sturdy material can be made to fit doorways to minimize the entry of floodwaters, although failure is common (see Figure 3-49). Effectiveness is increased significantly if a flexible gasket or sealant is provided, and the mounting hardware is designed to apply even pressure. Personnel must know where the materials are stored and be trained in

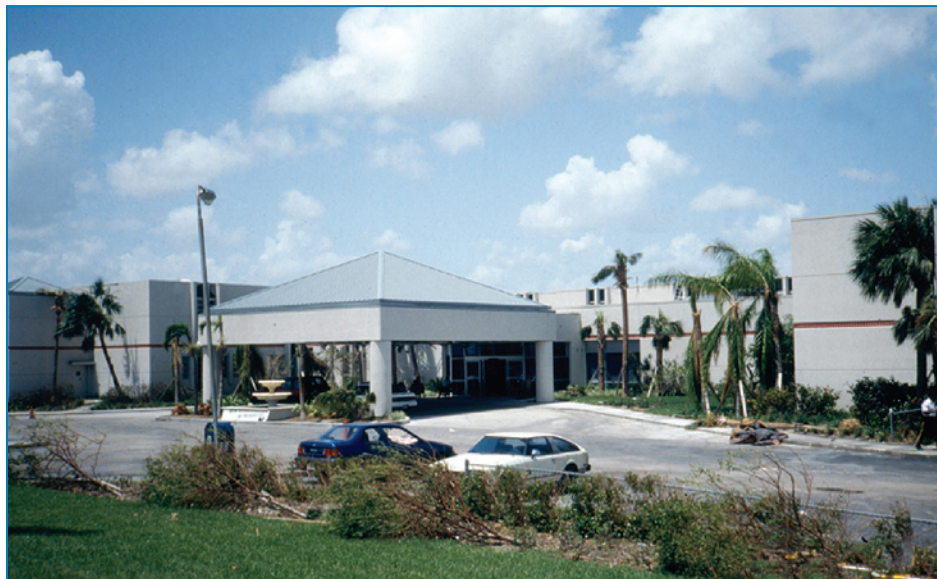
Figure 4-1:
Deering Hospital was evacuated after Hurricane Andrew due to water infiltration caused by roof covering, window, and door damage.

The 200-bed Deering Hospital opened shortly before Hurricane Andrew struck south Florida in 1992. Aggregate from the hospital's built-up roofs broke several windows, the roof covering was blown off in some areas (Figure 4-9), and the entrance doors at the emergency room were blown away. Because of extensive interior water damage, the entire hospital was evacuated after the storm and remained closed for 9 months.

Property damage: Property damage requires repairing/replacing the damaged components (or replacing the entire facility), and may require repairing/replacing interior building components, furniture, and other equipment, and mold remediation. As illustrated by Figures 4-1 and 4-8, even when damage to the building envelope is limited, such as blow-off of a portion of the roof covering or broken glazing, substantial water damage frequently occurs because heavy rains often accompany strong winds (particularly in the case of thunderstorms, tropical storms, hurricanes, and tornadoes).

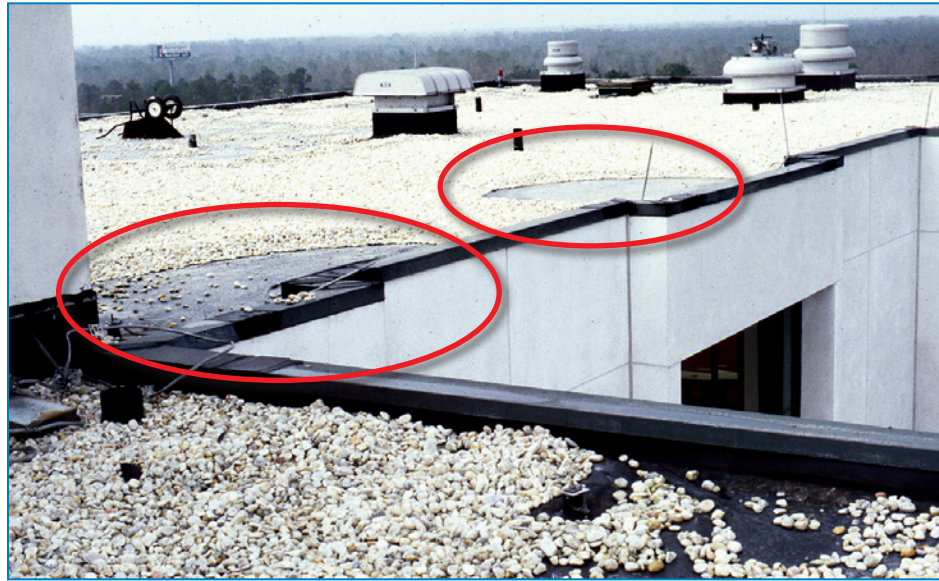
Figure 4-5:
Aggregate blow-off associated with building irregularities. Hurricane Hugo (South Carolina, 1989)

Building irregularities, such as re-entrant corners, bay window projections, a stair tower projecting out from the main wall, dormers, and chimneys can cause localized turbulence. Turbulence causes wind speed-up, which increases the wind loads in the vicinity of the building irregularity, as shown in Figures 4-5 and 4-6. Figure 4-5 shows the aggregate ballast on a hospital's single-ply membrane roof blown away at the re-entrant corner and in the vicinity of the corners of the wall projections at the window bays. The irregular wall surface created turbulence, which led to wind speed-up and loss of aggregate in the turbulent flow areas.

Wall collapse: Collapse of non-load-bearing exterior walls is common during hurricanes and tornadoes, but is less common during other storms. At the hospital shown in Figure 4-11, a portion of the non-load-bearing wall collapsed. Several windows were also broken by aggregate ballast blown from the hospital's roof (see Figure 4-5).

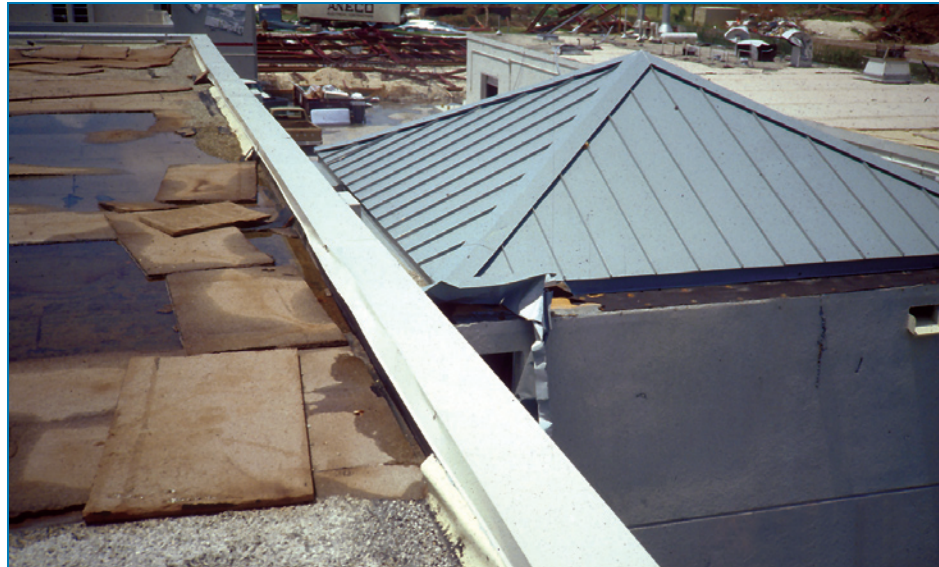
Figure 4-6 shows a stair tower at a hospital that caused turbulence resulting in wind speed-up. The speed-up increased the suction pressure on the base flashing along the parapet behind the stair tower. The built-up roof's base flashing was pulled out from underneath the coping because its attachment was insufficient to resist the suction pressure. The base flashing failure propagated and caused a large area of the roof membrane to lift and peel. Some of the wall covering on the stair tower was also blown away. Had the stair tower not existed, the built-up roof would likely not have been damaged. To avoid damage in the vicinity of building irregularities, attention needs to be given to the attachment of building elements located in turbulent flow areas.

Figure 4-6:
The irregularity created by the stair tower (covered with a metal roof) caused turbulence resulting in wind speed-up and roof damage. Hurricane Andrew (Florida, 1992)

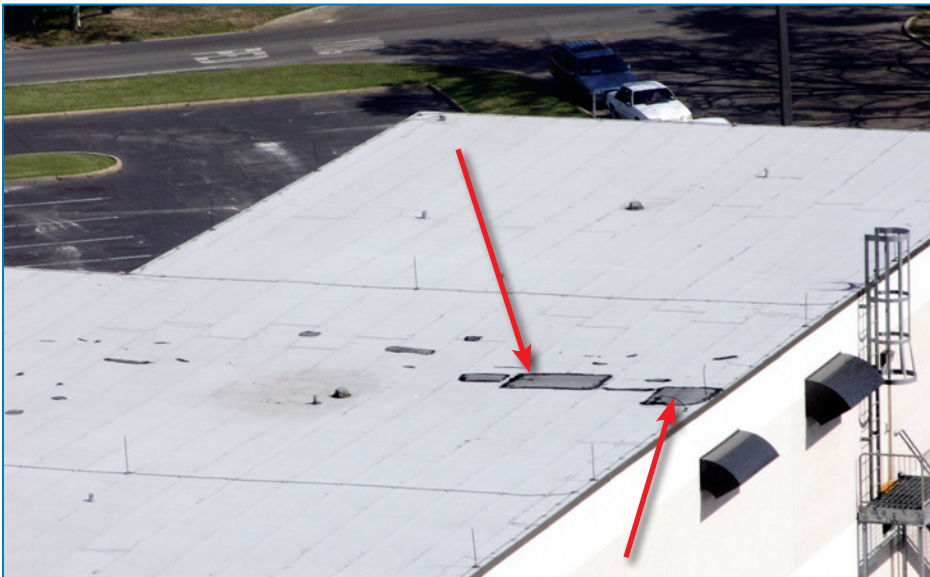
Figure 4-14: Numerous repairs where the modified bitumen roof membrane was punctured by missiles. Water from the punctured membrane entered the surgical suite.

The West Florida Hospital (J on Figure 4-13) and several of the other buildings on the campus experienced a variety of damages during the storm. The roof membrane was punctured in several places by windborne missiles and by damaged rooftop equipment (see Figures 4-14 to 4-16).

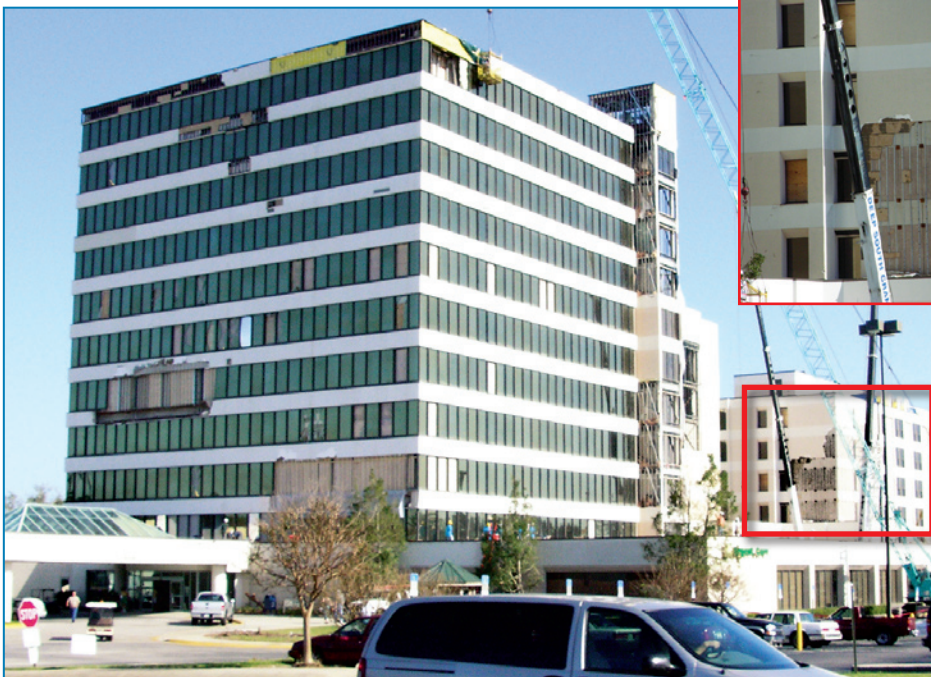
Figure 4-19:
EIFS debris blown off the hospital building (Item J on Figure 4-13) in the background (red square) broke numerous windows in the MOB (item G on figure 4-13) in the foreground.

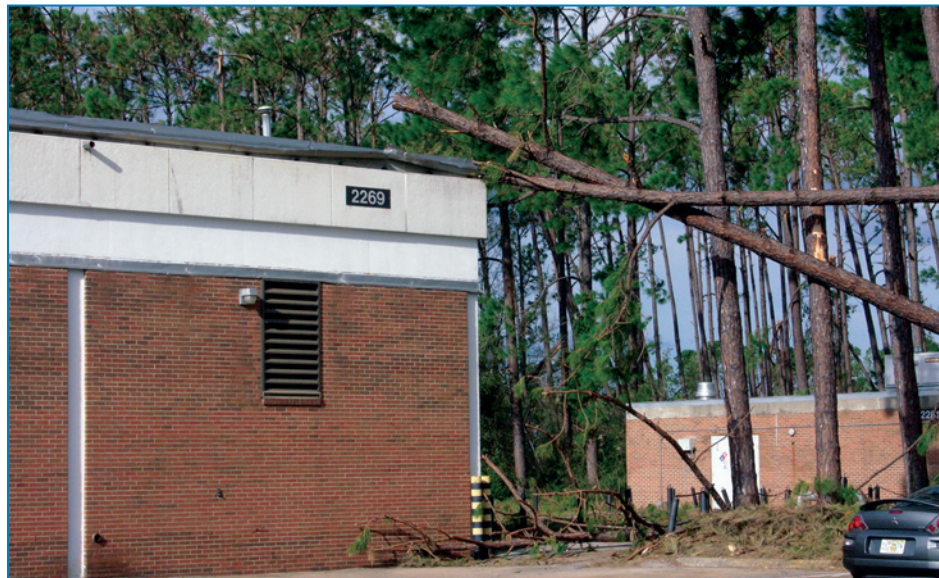
Trees with trunks larger than 6 inches in diameter, poles (e.g., light fixture poles, flagpoles, and power poles), or towers (e.g., electrical transmission and large communication towers) should not be placed near the building. Falling trees, poles, and towers can severely damage a hospital and injure the occupants (see Figure 4-24). Large trees can crash through pre-engineered metal buildings and wood frame construction. Falling trees can also rupture roof membranes and break windows.

Figure 4-24:
The roof membrane on this hospital's materials management facility was ruptured by falling trees. Hurricane Ivan (Florida, 2004)

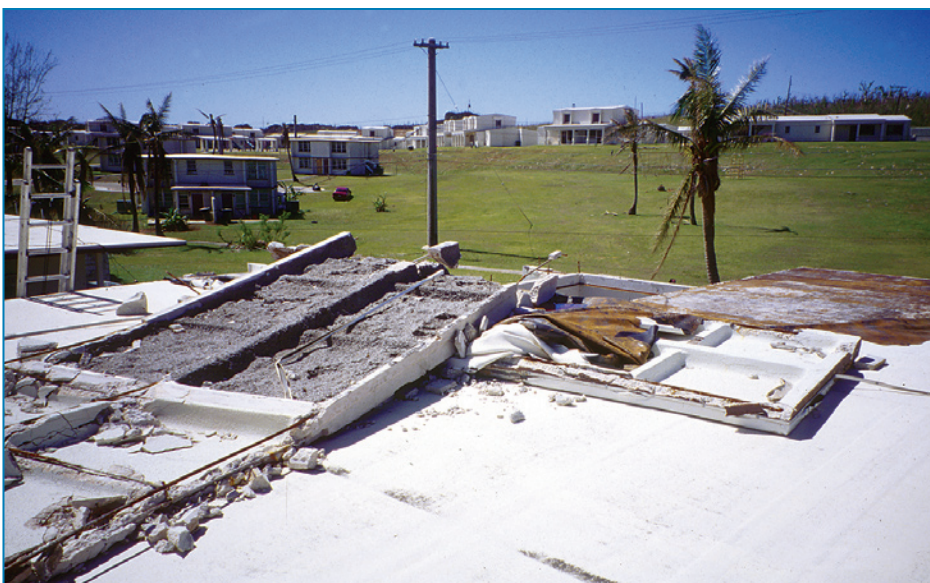
Figure 4-31:
Portions of this waffled precast concrete roof deck were blown off. Typhoon Paka (Guam, 1997)

- For attaching wood-sheathed roof decks, screws, ring-shank, or screw-shank nails are recommended in the corner regions of the roof. Where the basic wind speed is greater than 90 mph, these types of fasteners are also recommended for the perimeter regions of the roof.
- For precast concrete decks it is recommended that the deck connections be designed to resist the design uplift loads because the deck dead load itself is often insufficient to resist the uplift. The deck in Figure 4-31 had bolts to provide uplift resistance; however, anchor plates and nuts had not been installed. Without the anchor plates, the dead load of the deck was insufficient to resist the wind uplift load.
