Risk Management Series

Design Guide

for Improving Hospital Safety
in Earthquakes, Floods, and High Winds

FEMA 577 / June 2007

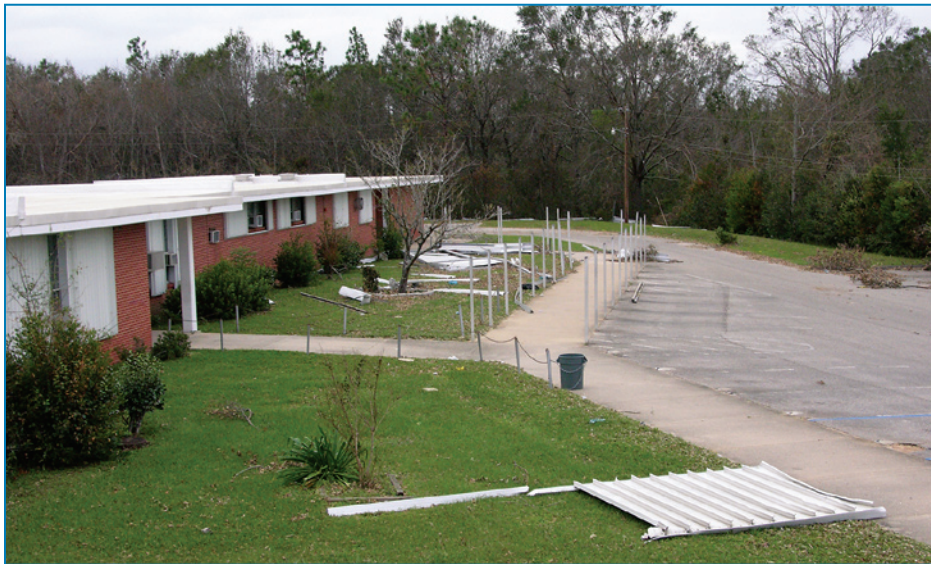
Figure 4-33:
The destroyed walkway canopy in front of this building became wind-borne debris. Hurricane Ivan (Florida, 2004)

- Walkway and entrance canopies are often damaged during high winds (see Figure 4-33). Wind-borne debris from damaged canopies can damage nearby buildings and injure people, hence these elements should also receive design and construction attention.

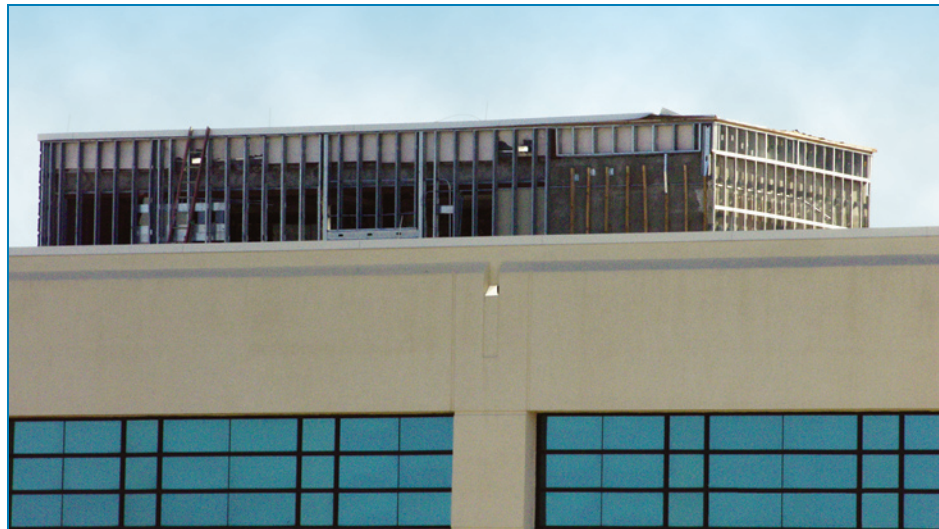
Figure 4-48:

The wall covering blew off the penthouse at this hospital complex, allowing rainwater to destroy the elevator controls. Hurricane Ivan (Florida, 2004)

To ensure the continuity of elevator service, elevator penthouse walls must possess adequate wind and water resistance. If the walls blow away or water leaks through the wall system, the elevator controls and/or motors can be destroyed. Loss of elevators may critically affect facility operations (see Figures 4-22 and 4-48). The restoration of elevator service can take weeks, even with expedited work.

EIFS: Figure 4-59 shows typical EIFS assemblies. Figure 4-48 and several figures in Section 4.2.1.3 show EIFS blow-off. In these cases, the molded expanded polystyrene (MEPS) was attached to gypsum board, which in turn was attached to metal studs or hat channels. The gypsum board detached from the studs/hat channels, which is a common EIFS failure mode. When the gypsum board on the exterior side of the studs is blown away, it is common for gypsum board on the interior side to also be blown off. The opening allows the building to become fully pressurized and allows the entrance of wind-driven rain. Other common types of failure include wall framing failure, separation of the MEPS from its substrate, and separation of the synthetic stucco from the MEPS.

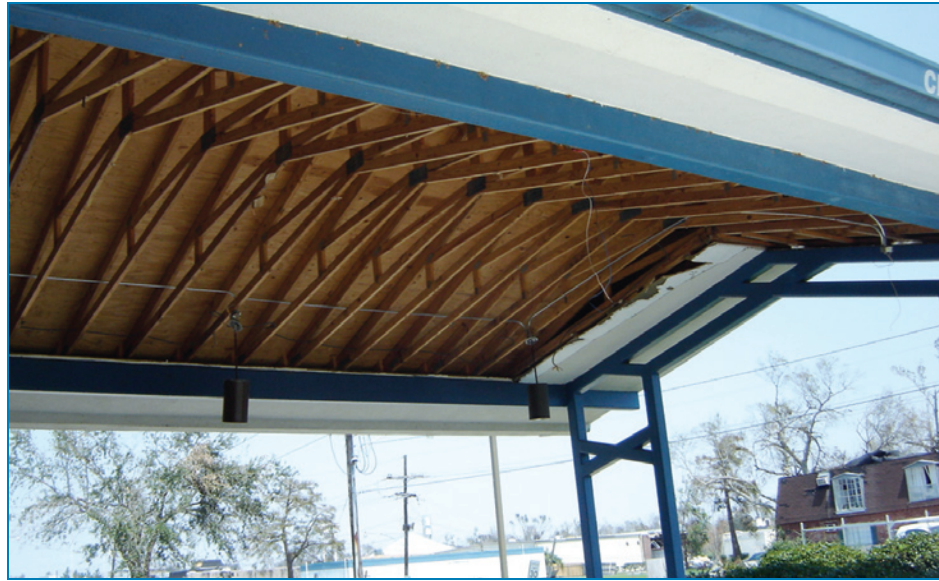
Figure 4-50:
Hospital canopy
damage. Hurricane
Katrina (Louisiana,
2005)

Soffits: Depending on the wind direction, soffits can experience either positive or negative pressure. Besides the cost of repairing the damaged soffits, wind-borne soffit debris can cause property damage and injuries (see Figures 4-49 and 4-50). Failed soffits may also provide a convenient path for wind-driven rain to enter the building. Storm-damage research has shown that water blown into attic spaces after the loss of soffits can cause significant damage and the collapse of ceilings. Even in instances where soffits remain in place, water can penetrate through soffit vents and cause damage. At this time, there are no known specific test standards or design guidelines to help design wind- and water-resistant soffits and soffit vents.

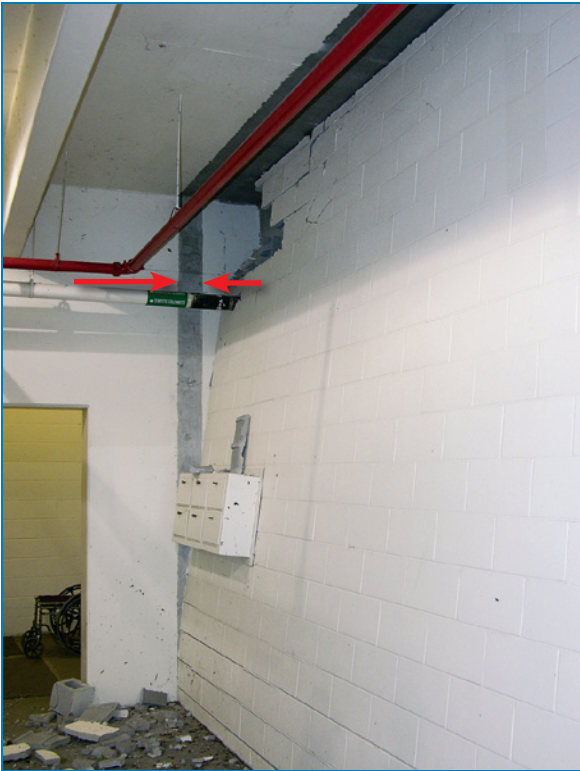
Figure 4-51:
The red arrows show the original location of a CMU wall that nearly collapsed following a rolling door failure. Hurricane Charley (Florida, 2004)

Interior non-load-bearing masonry walls: Special consideration should also be given to interior non-load-bearing masonry walls. Although these walls are not required by building codes to be designed to resist wind loads, if the exterior glazing is broken, or the exterior doors are blown away, the interior walls could be subjected to significant load as the building rapidly becomes fully pressurized. To avoid casualties, it is recommended that interior non-load-bearing masonry walls adjacent to occupied areas be designed to accommodate loads exerted by a design wind event, using the partially enclosed pressure coefficient (see Figure 4-51). By doing so, wall collapse may be prevented if the building envelope is breached. This recommendation is applicable to hospitals located in areas with a basic wind speed greater than 120 mph, and to hospitals in tornado-prone regions that do not have shelter space designed in accordance with FEMA 361.

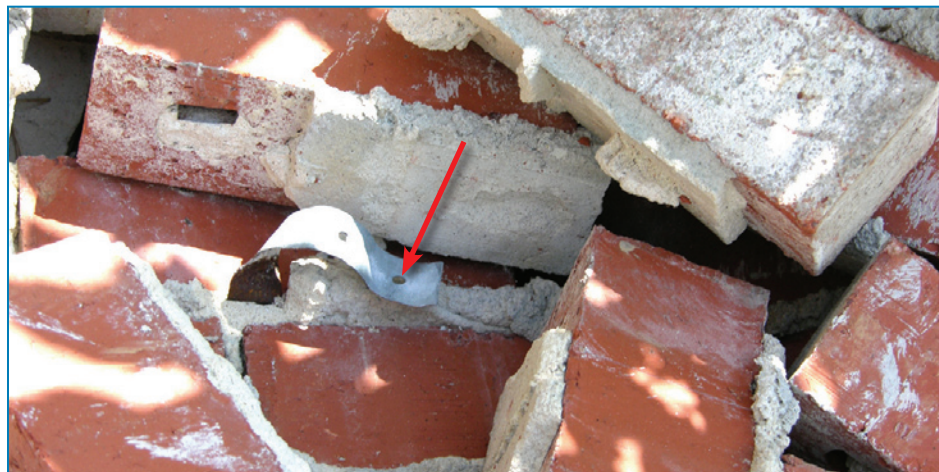
Figure 4-54: Misalignment of the tie reduces the embedment and promotes veneer failure.

Ties are often installed before brick laying begins. When this is done, ties are often improperly placed above or below the mortar joints. When misaligned, the ties must be angled up or down to be embedded into the mortar joints (Figure 4-54). Misalignment not only reduces the embedment depth, but also reduces the effectiveness of the ties, because wind forces do not act in parallel direction to the ties.

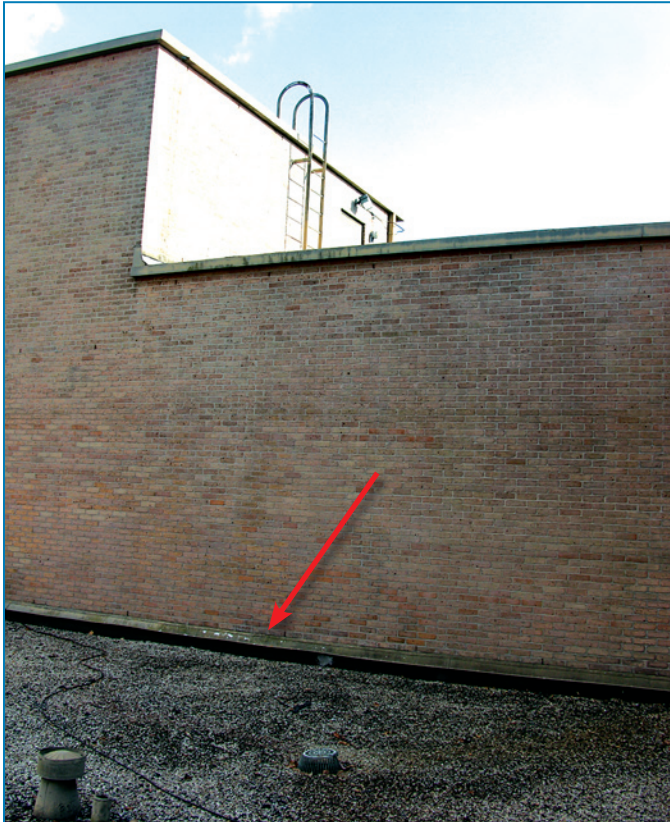
Figure 4-58: Water leaked inside along the base of the brick veneer walls (red arrow). Hurricane Katrina (Louisiana, 2005)

To avoid water leaking into the building, it is important that weep holes be adequately spaced and not be blocked during brick installation, and that through-wall flashings be properly designed and installed. When the base of the brick veneer occurs near grade, the grade should be designed so that it occurs several inches below the weeps so that drainage from the weeps is not impeded. Also, landscaping should be kept clear of weeps so that vegetation growth does not cause blockage of weeps. At the hospital shown in Figure 4-58, water leaked into the building along the base of many of the brick veneer walls. When high winds accompany heavy rain, a substantial amount of water can be blown into the wall cavity.

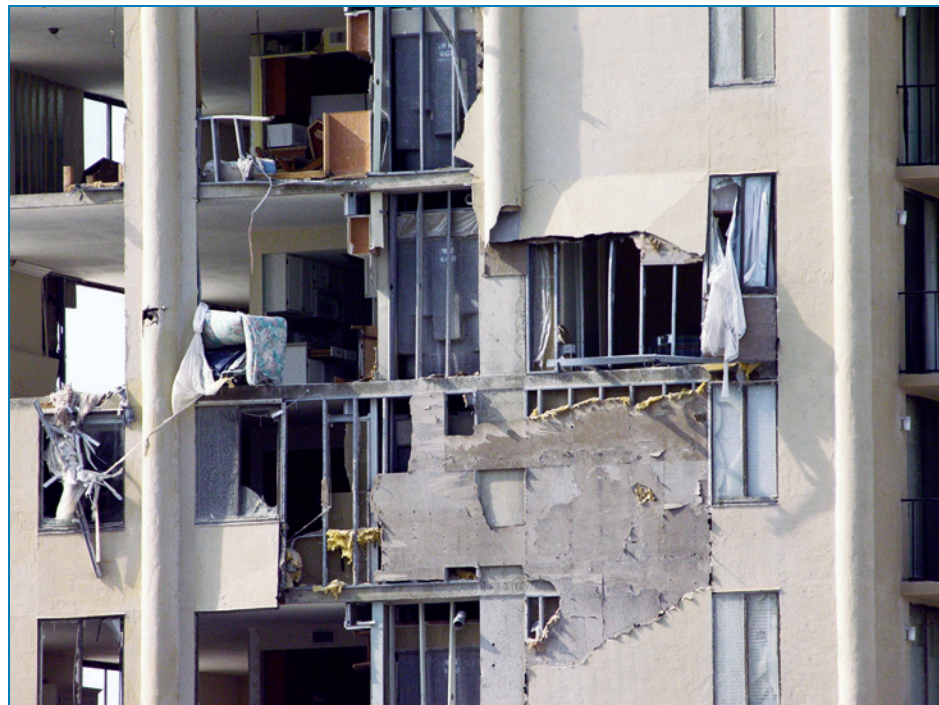
Figure 4-61:
The stucco wall failure was caused by inadequate attachment between the stud tracks and the building's structure. Hurricane Ivan (Florida, 2004)

Stucco over studs: Wind performance of traditional stucco walls is similar to the performance of EIFS, as shown in Figure 4-61. In several areas the metal stud system failed; in other areas the gypsum sheathing blew off the studs; and in other areas, the metal lath blew off the gypsum sheathing. The failure shown in Figure 4-61 illustrates the importance of designing and constructing wall framing (including attachment of stud tracks to the building and attachment of the studs to the tracks) to resist the design wind loads.

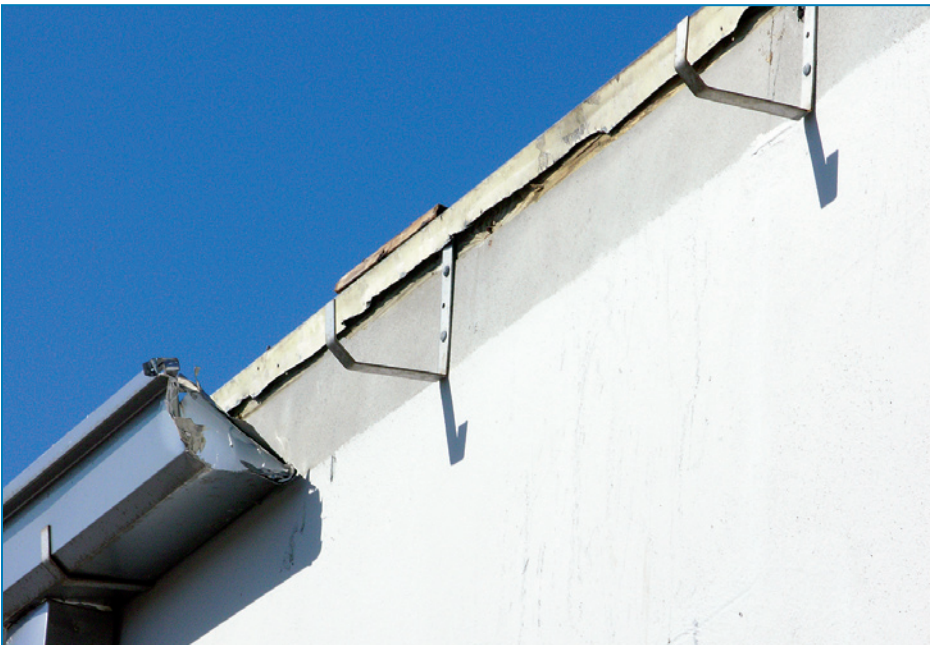
Figure 4-68:
This gutter, supported by a type of bracket that provides no significant uplift resistance, failed when wind lifted it, together with the metal edge flashing that lapped into the gutter. Hurricane Francis (Florida, 2004)

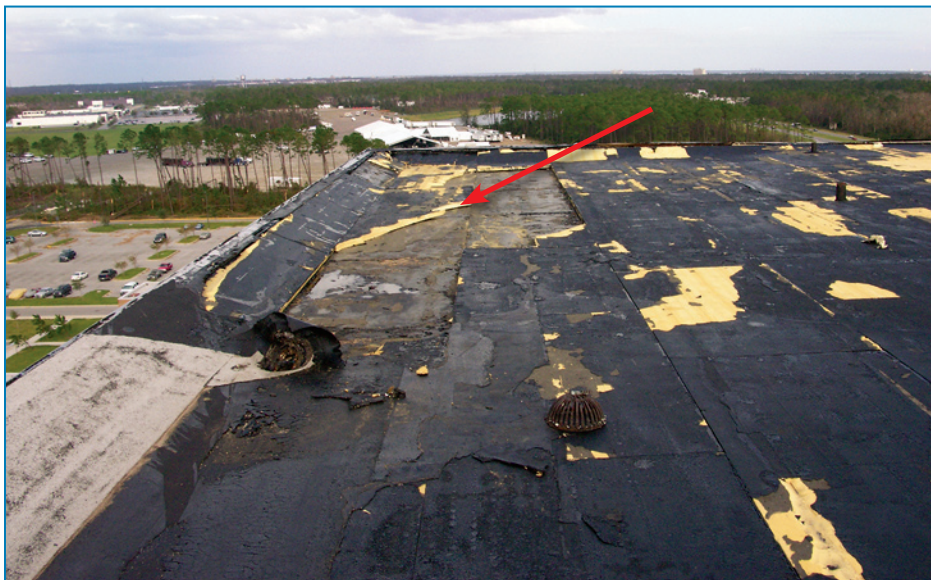
Figure 4-71:
The blown off insulation (red arrow) may have initiated blow off of the roof membrane. Hurricane Ivan (Florida, 2004)

When fully adhering insulation boards, it is recommended that the boards be no larger than 4 feet by 4 feet. It is also recommended that the board thickness not exceed 2 inches (1½ inches is preferable). Use of small thin boards makes it easier for the contractor to conform the boards to the substrate. At the hospital shown in Figure 4-71, 4 foot by 8 foot insulation boards were set in hot asphalt over a concrete deck. A few of the boards detached from the deck. The boards may have initiated the membrane blow off, or the membrane blow off may have been initiated by lifting and peeling of the metal edge flashing, in which case, loss of the insulation boards was a secondary failure.

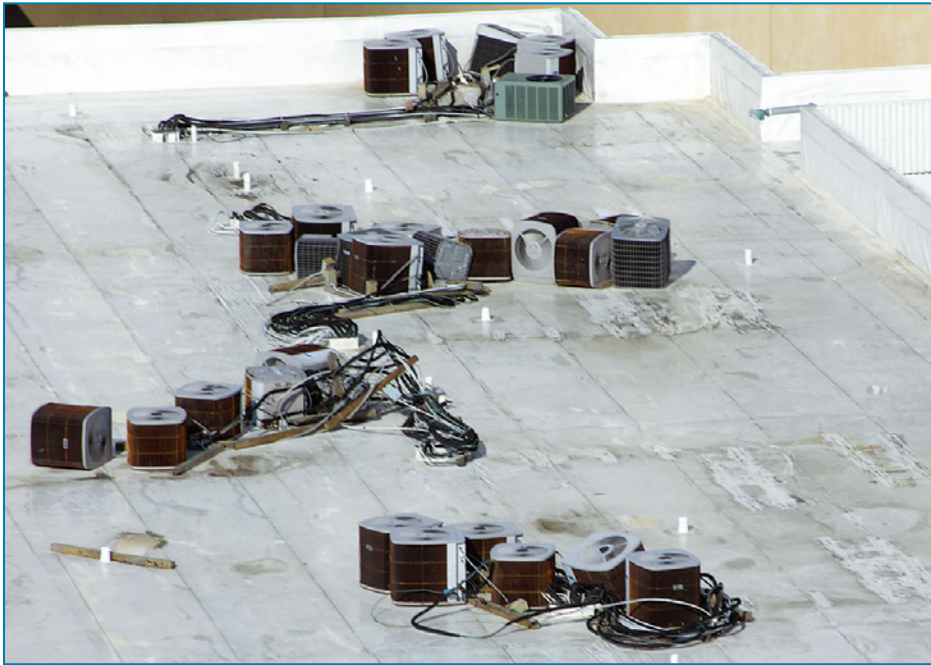
Figure 4-90:
Sleeper-mounted condensers displaced by high winds. Hurricane Katrina (Mississippi, 2005)

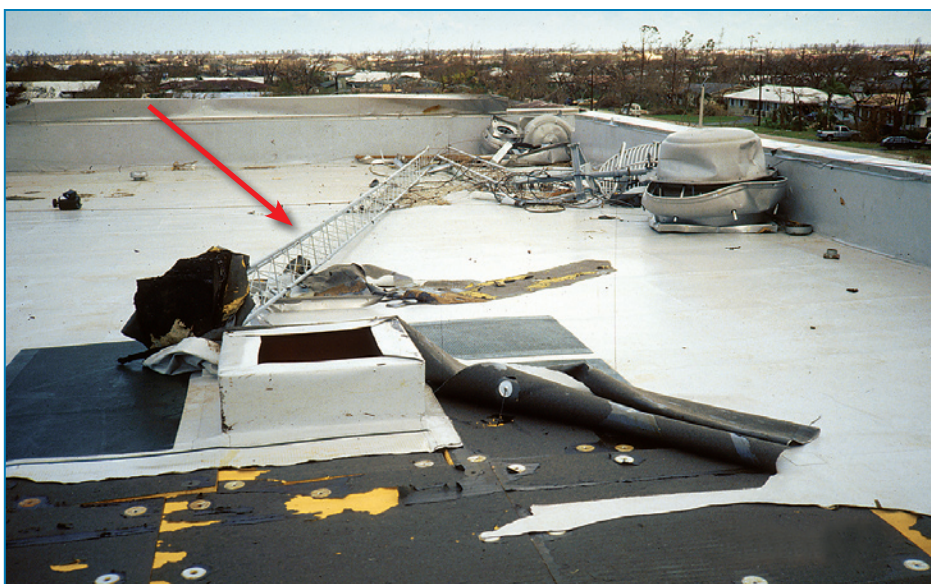
Figure 4-95: The collapse of the antenna tower caused progressive peeling of the roof membrane. Also note that the exhaust fan blew off the curb, but the high parapet kept it from blowing off the roof. Hurricane Andrew (Florida, 1992)

Collapse of both large and small communication towers at hospitals is quite common during high-wind events (see Figures 4-15 and 4-95). These failures often result in complete loss of communication capabilities. In addition to the disruption of communications, collapsed towers can puncture roof membranes and allow water leakage into the hospital, unless the roof system incorporated a secondary membrane (as discussed in Section 4.3.3.8). At the tower shown in Figure 4-95, the anchor bolts were pulled out of the deck, which resulted in a progressive peeling of the fully adhered single-ply roof membrane. Tower collapse can also injure or kill people.

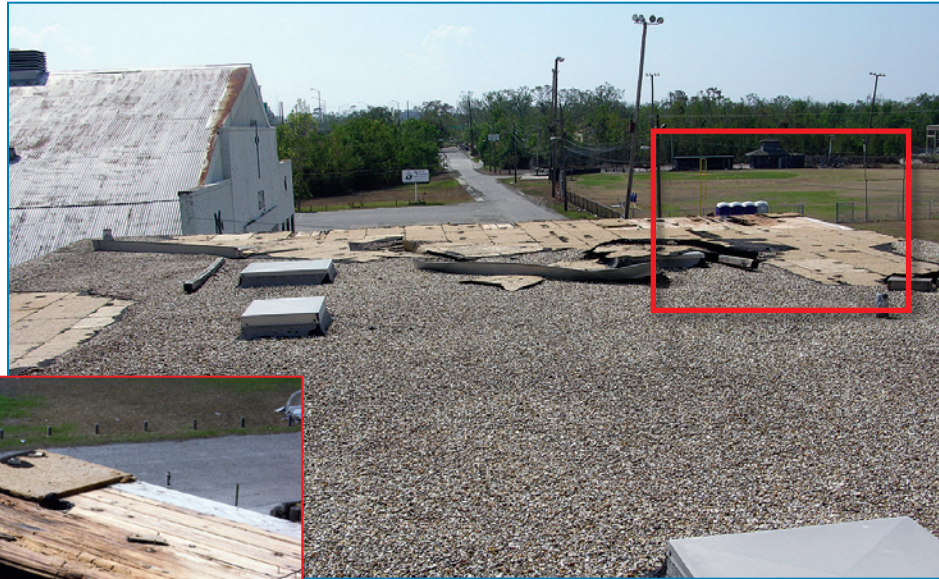
Figure 4-119:

The built-up roof was blown off after a few of the rotted wood planks detached from the joists. Hurricane Katrina (Mississippi, 2005)

When planning the replacement of a roof covering, it is recommended that all existing roof covering be removed down to the deck rather than simply re-covering the roof. Tearing off the covering provides an opportunity to evaluate the structural integrity of the deck and correct deck attachment and other problems. For example, if a roof deck was deteriorated due to roof leakage (see Figure 4-119), the deterioration would likely not be identified if the roof was simply re-covered. By tearing off

down to the deck, deteriorated decking like that shown in Figure 4-119 can be found and replaced. In addition, it is recommended that the attachment of the wood nailers at the top of parapets and roof edges be evaluated and strengthened where needed, to avoid blow-off and progressive lifting and peeling of the new roof membrane (see Figure 4-126).

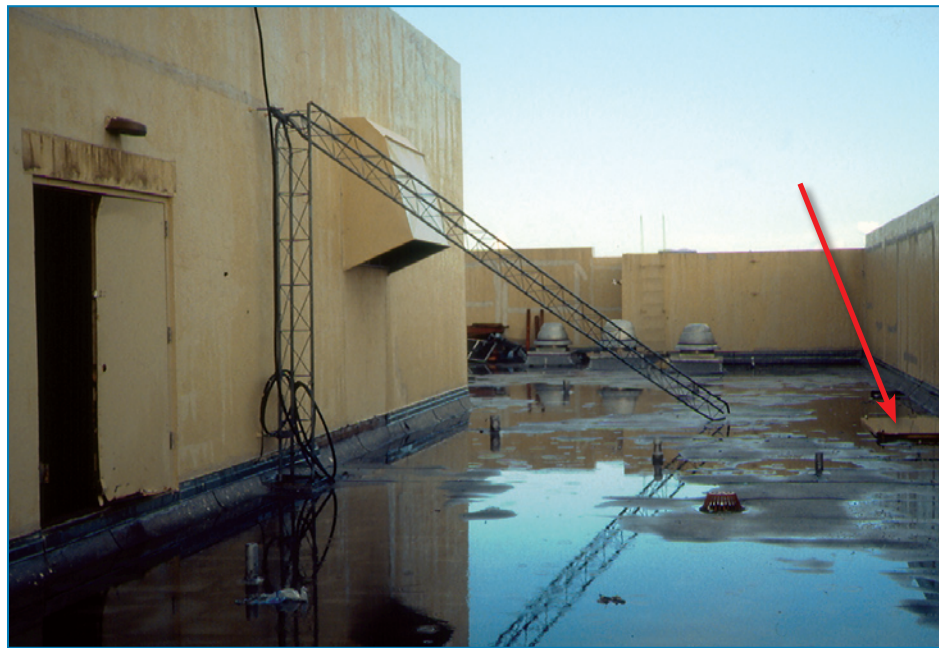
Figure 4-121:
The antenna at this hospital collapsed and was whipped back and forth across the roof membrane. Hurricane Andrew (Florida, 1992)

Antenna collapse is very common. Besides loss of communications, collapsed masts can puncture roof membranes or cause other building damage as shown in Figure 4-121. This case also demonstrates the benefits of a high parapet. Although the roof still experienced high winds that blew off this penthouse door, the parapet prevented the door from blowing off the roof (red arrow in Figure 4-121).

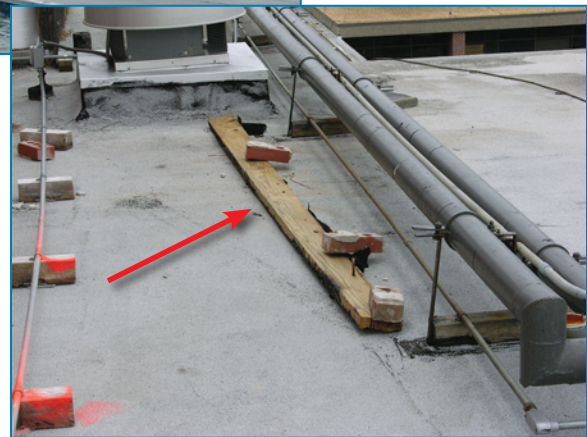
Figure 4-126:
The roof covering blew off – an emergency roof covering had been installed (blue arrow). The failure was caused by the inadequately attached nailer (see inset). The leaning mast at the right is a ladder (yellow arrow), with an extension for communications and an anemometer for the nearby heliport.

Water entered the hospital at damaged rooftop equipment (Figure 4-124), and at areas where the roof membrane blew off (Figures 4-125 and 4-126) and where it was punctured. The roof failure shown in Figure 4-126 was caused by an inadequately attached edge nailer anchored to the brick wall. Failure of the nailer caused a progressive lifting and peeling of the roof membrane. Gutters and downspouts were blown off and a few windows were broken. The elevator penthouse roof was damaged at the psychiatric hospital (Figure 4-127) and the MOBs (Figure 4-125).

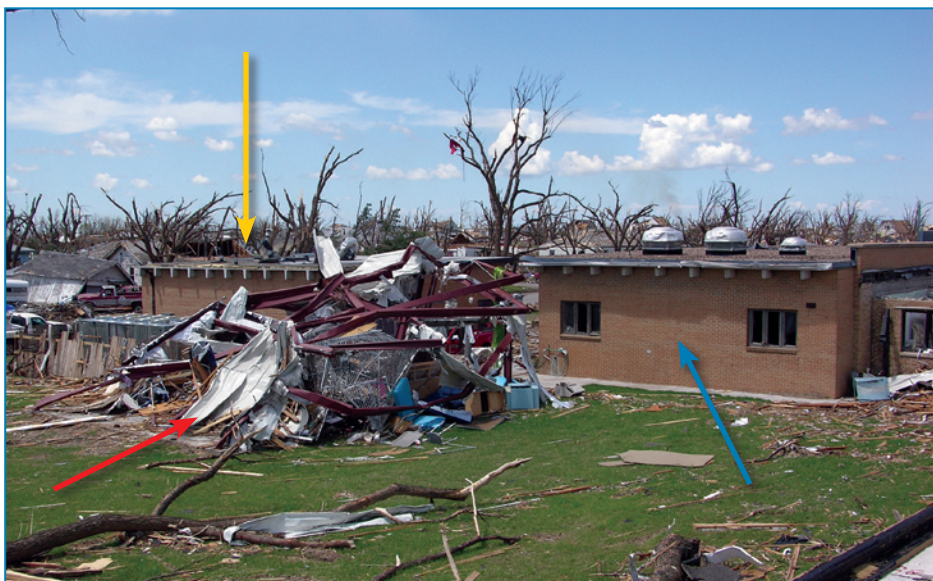
Figure 4-131:
The building housing the generator is shown by the yellow arrow. The kitchen facility is shown by the blue arrow. The red arrow shows the collapsed storage building.

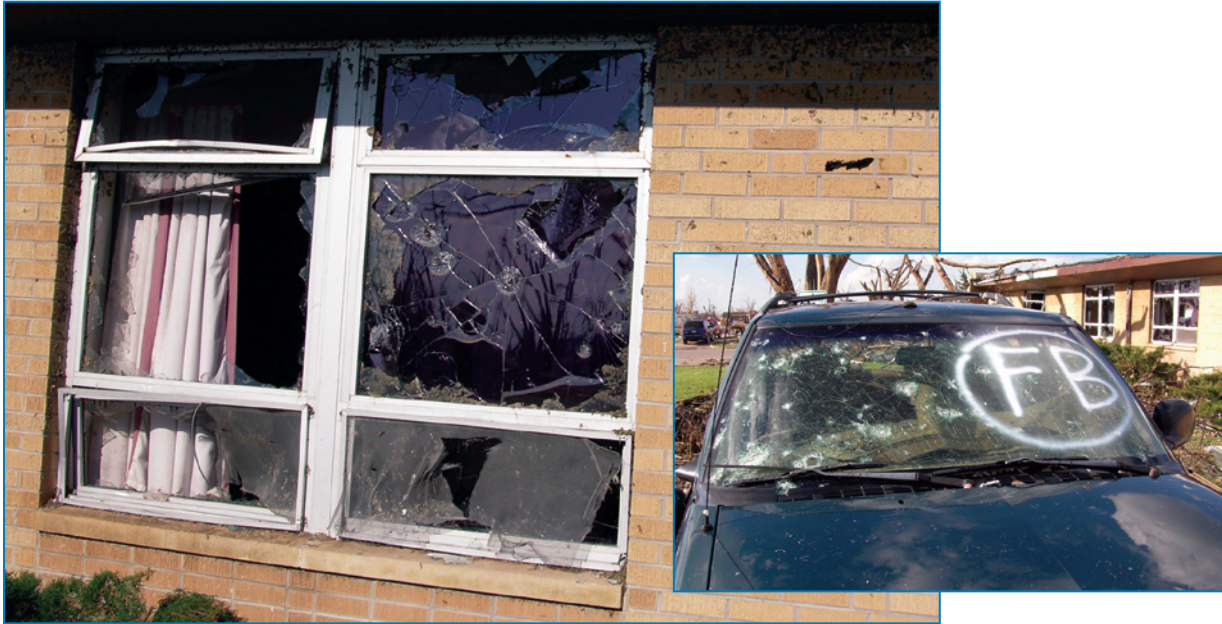
Figure 4-135:

All six panes of glass were broken. The craters shown in the right center pane and at the vehicle windshield were caused by the large aggregate blown from the ballasted single-ply membranes.

Aggregate from the ballasted single-ply membrane roofs broke several windows (Figure 4-135), and pieces of the large aggregate (1½-inches in diameter, nominal) were found inside the building. Windows were also broken by 2x wood framing (Figure 4-136).

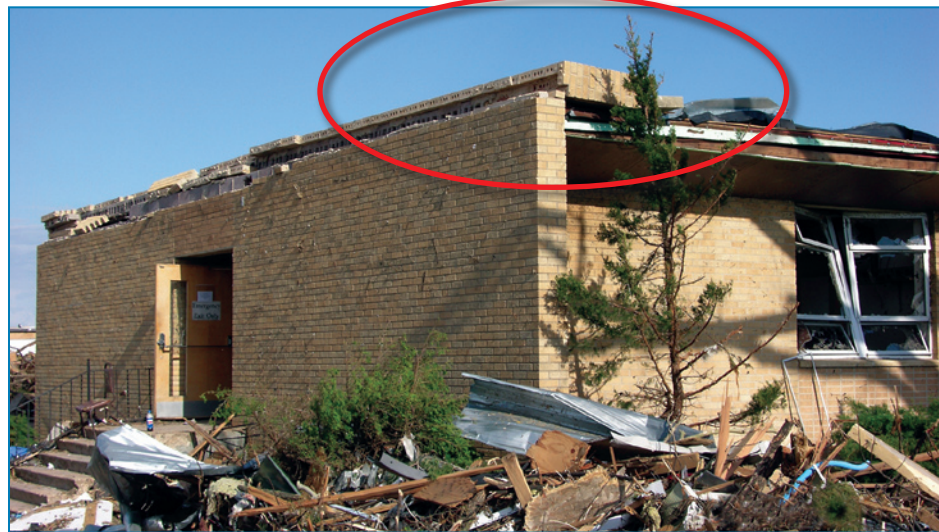
Figure 4-139:
Collapsed unreinforced masonry parapet. Note the broken windows.

If the parapet is constructed of masonry, it is recommended that its wind resistance be evaluated and strengthened if found to be inadequate. The masonry parapet shown in Figure 4-139 fell onto the roof. Had it fallen in the other direction, it would have blocked the entry and would have had the potential to cause injury.

There was no apparent structural damage to the 1965 addition. However, the unreinforced brick/CMU parapet shown in Figure 4-139 fell onto the roof, rather than in the other direction, where it would have blocked the entry and possibly could have caused injuries. Virtually all of the exterior windows were broken (see Figures 4-135 and 4-136). The roof insulation and aggregate-ballasted single-ply roof membrane were blown off. The wood roof structure blew off the majority of the 1982 addition (Figures 4-133 and 4-140), and virtually all of the exterior windows were broken.

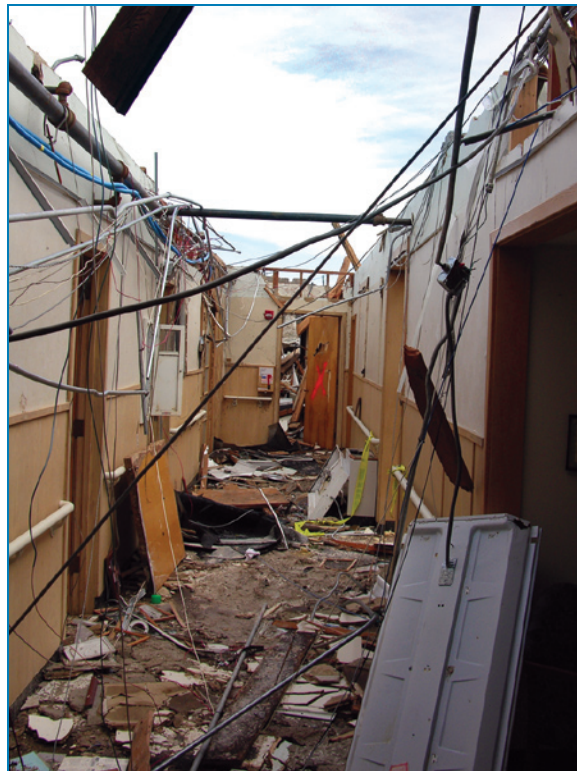
Figure 4-142:
View of a main
corridor in the 1982
addition

in a particular facility; by that time, it will be too late. If refuge areas have not been identified beforehand, occupants will take cover wherever they can, frequently in very dangerous places. Corridors, as shown in Figure 4-142, sometimes provide protection, but they can also be death traps.

The loss of life and avoidance of injuries was attributed to three factors. 1) A tornado warning was issued by the National Weather Service about 20 minutes before the tornado struck, and the hospital's staff was aware of the warning. 2) The hospital had a tornado evacuation plan and there was sufficient time to execute the plan. 3) Although it is believed that the basement was not specifically designed as a tornado shelter, it provided a safe area of refuge for patients and staff. For hospitals located in tornado-prone regions, the experience from this tornado demonstrates the importance of having a pre-identified, best available refuge area (or preferably a FEMA 361-compliant shelter). Although small interior rooms and corridors sometimes provide adequate protection during tornadoes, unless specifically designed as a tornado shelter, they often provide inadequate protection, as shown in Figure 4-142.

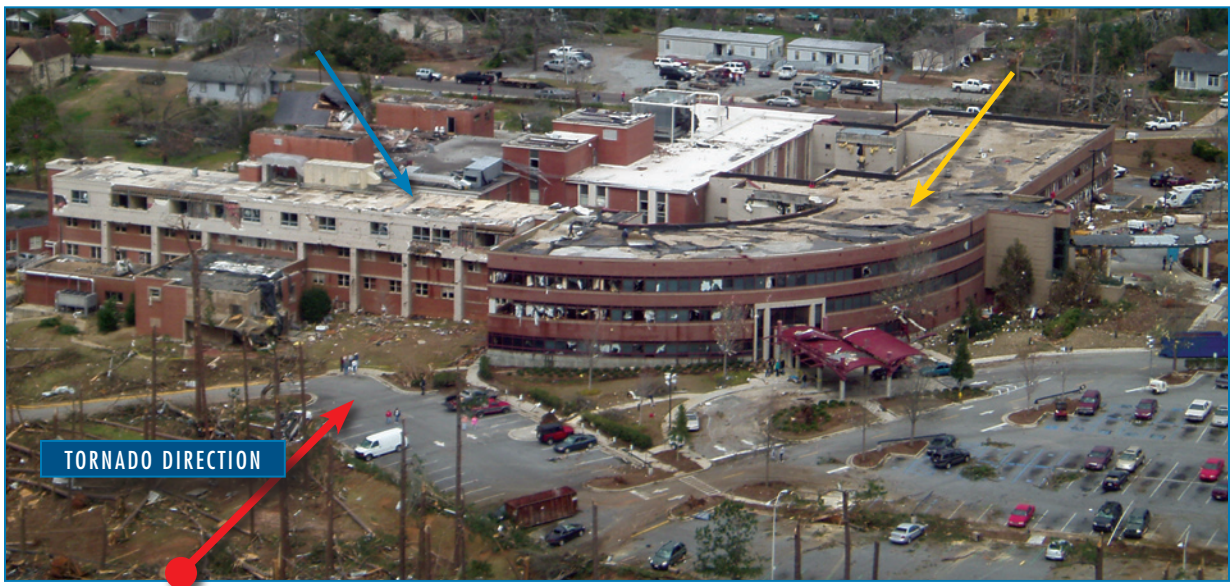
Figure 4-143:

Aerial view of the facility after it was struck by the tornado. The red arrow indicates the general direction of the tornado. The blue arrow shows the 1953 building, and the yellow arrow shows the 1999 building. The 1975 and 1983 additions are adjacent to and behind the 1953 and 1999 buildings.
