Rapid Visual Screening of Buildings for Potential Seismic Hazards

A Handbook

FEMA 154, Edition 2 / March 2002

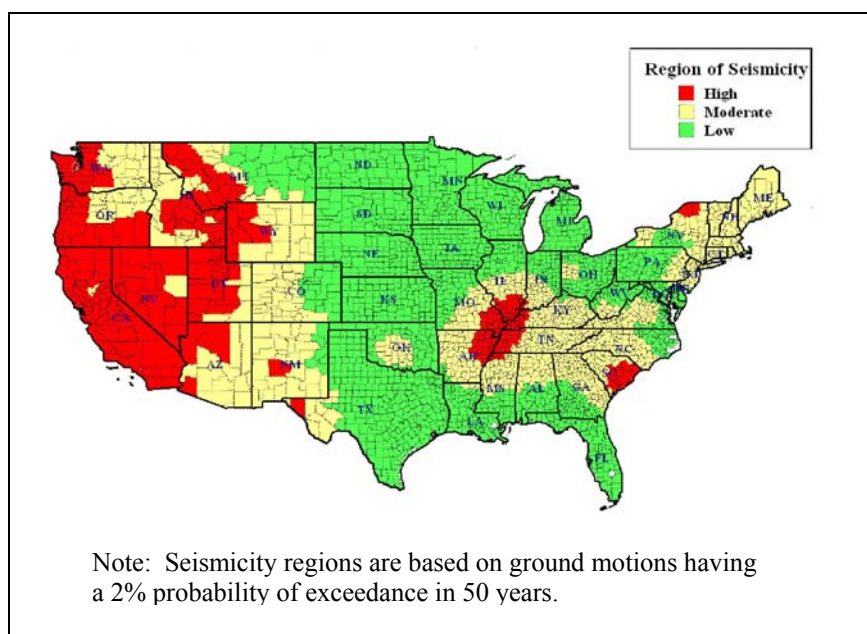
Figure 1-1 High, moderate, and low seismicity regions of the conterminous United States. A different RVS Data Collection Form has been developed for each of these regions. Enlarged maps are available in Appendix A.

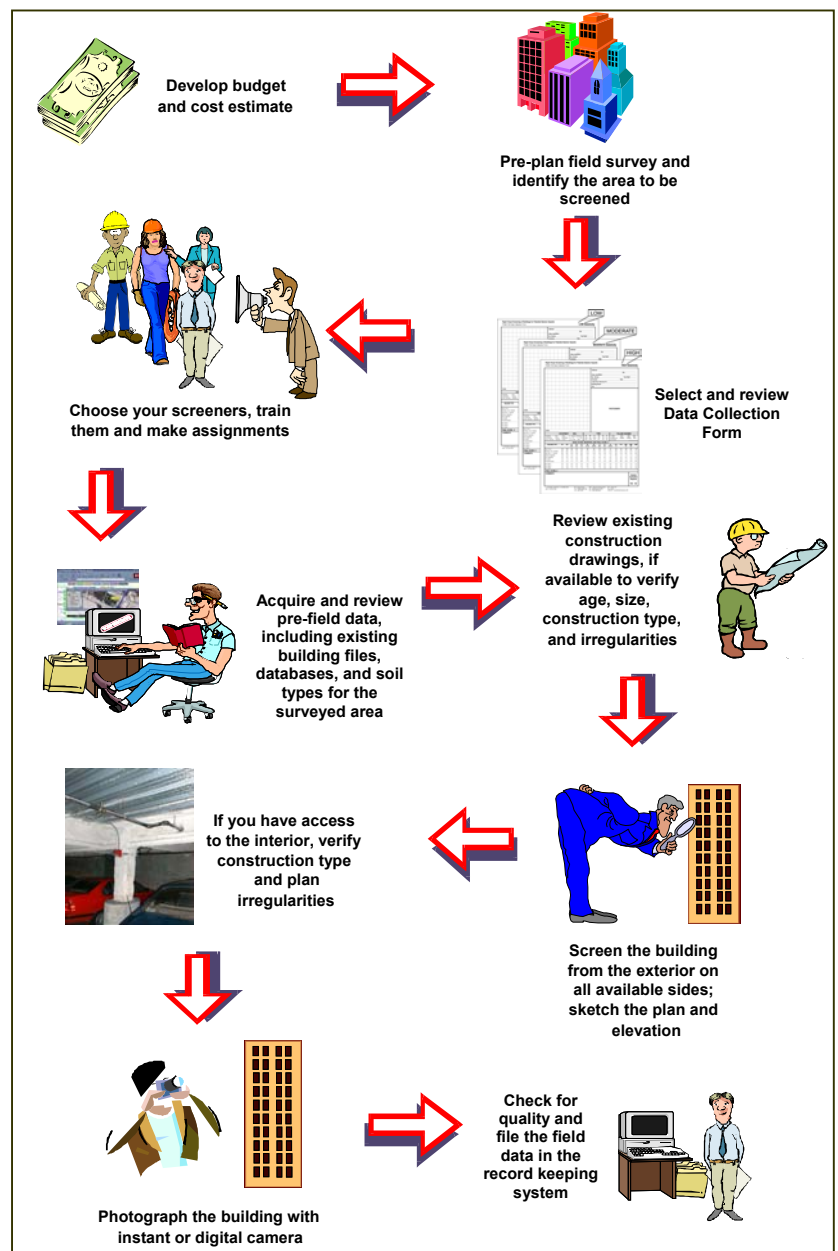
Figure 2-1 Rapid visual screening implementation sequence.

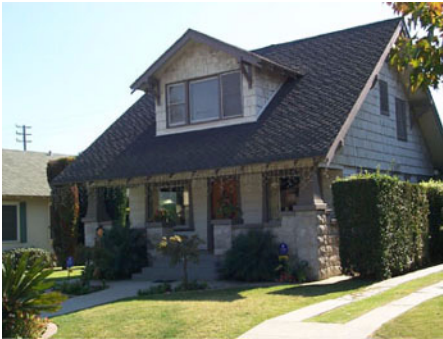
<i>Building Identifier</i>	<i>Photograph</i>	<i>Basic Structural Hazard Score</i>	<i>Characteristics and Performance</i>
<p>W1 Light wood frame residential and commercial buildings equal to or smaller than 5,000 square feet</p>

<p>H = 2.8 M = 5.2 L = 7.4</p>	<ul style="list-style-type: none"> ● Wood stud walls are typically constructed of 2-inch by 4-inch vertical wood members set about 16 inches apart (2-inch by 6-inch for multiple stories). ● Most common exterior finish materials are wood siding, metal siding, or stucco. ● Buildings of this type performed very well in past earthquakes due to inherent qualities of the structural system and because they are lightweight and low rise. ● Earthquake-induced cracks in the plaster and stucco (if any) may appear, but are classified as non-structural damage. ● The most common type of structural damage in older buildings results from a lack of connection between the superstructure and the foundation, and inadequate chimney support.

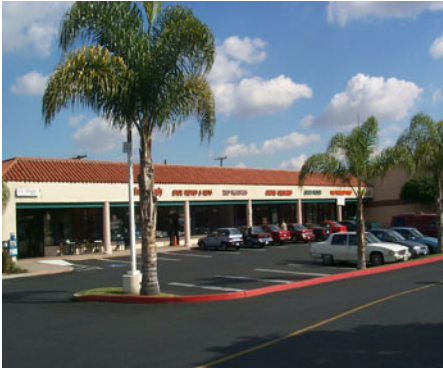
<p>W2 Light wood frame buildings greater than 5,000 square feet</p>

<p>H = 3.8 M = 4.8 L = 6.0</p>	<ul style="list-style-type: none"> ● These are large apartment buildings, commercial buildings or industrial structures usually of one to three stories, and, rarely, as tall as six stories.

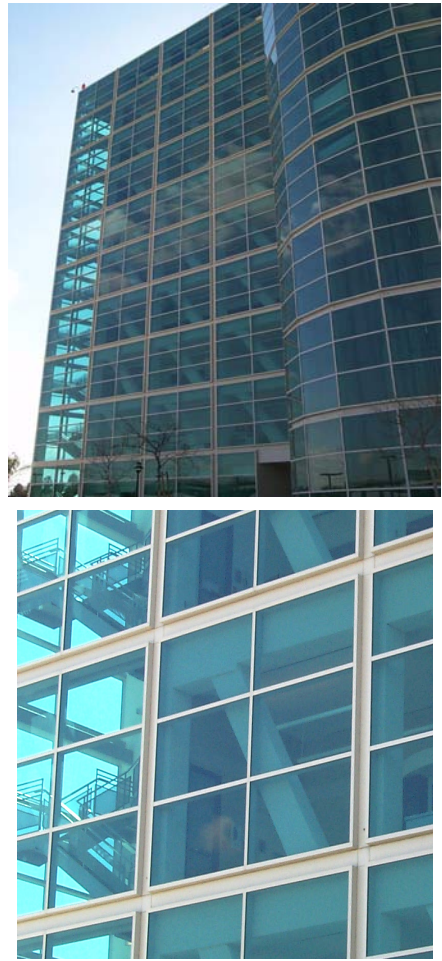
<p>Zoom-in of upper photo</p>	<p>H = 3.0 M = 3.6 L = 4.8</p>	<ul style="list-style-type: none"> • These buildings are braced with diagonal members, which usually cannot be detected from the building exterior. • Braced frames are sometimes used for long and narrow buildings because of their stiffness. • From the building exterior, it is difficult to tell the difference between steel moment frames, steel braced frames, and steel frames with interior concrete shear walls. • In recent earthquakes, braced frames were found to have damage to brace connections, especially at the lower levels.

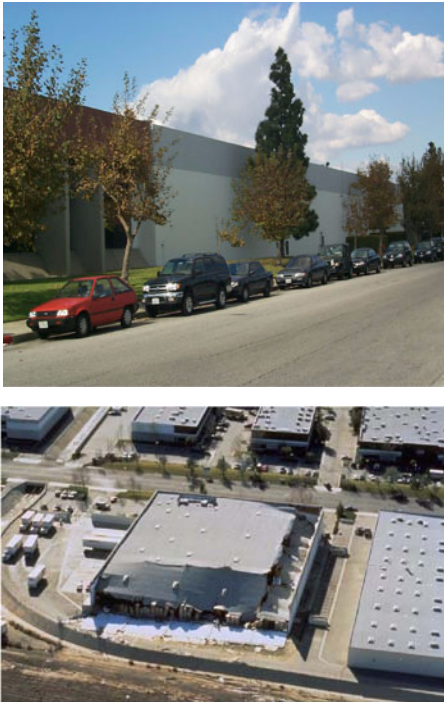
<i>Building Identifier</i>	<i>Photograph</i>	<i>Basic Structural Hazard Score</i>	<i>Characteristics and Performance</i>
<p>PC1 Tilt-up buildings</p>

<p>Partial roof collapse due to failed diaphragm-to-wall connection</p>	<p>H = 2.6 M = 3.2 L = 4.4</p>	<ul style="list-style-type: none"> ● Tilt-ups are typically one or two stories high and are basically rectangular in plan. ● Exterior walls were traditionally formed and cast on the ground adjacent to their final position, and then “tilted-up” and attached to the floor slab. ● The roof can be a plywood diaphragm carried on wood purlins and glulam beams or a light steel deck and joist system, supported in the interior of the building on steel pipe columns. ● Weak diaphragm-to-wall anchorage results in the wall panels falling and the collapse of the supported diaphragm (or roof).

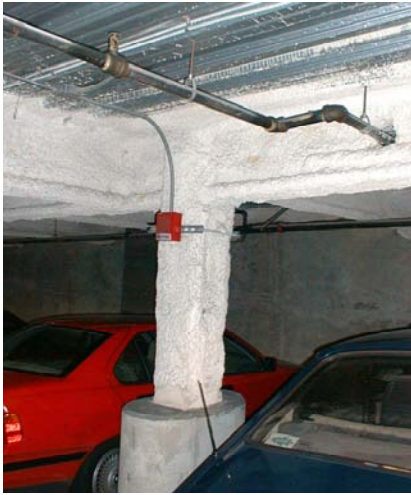
Figure 3-11 Interior view showing fire-proofed columns and beams, which indicate a steel building (S1, S2, or S4).

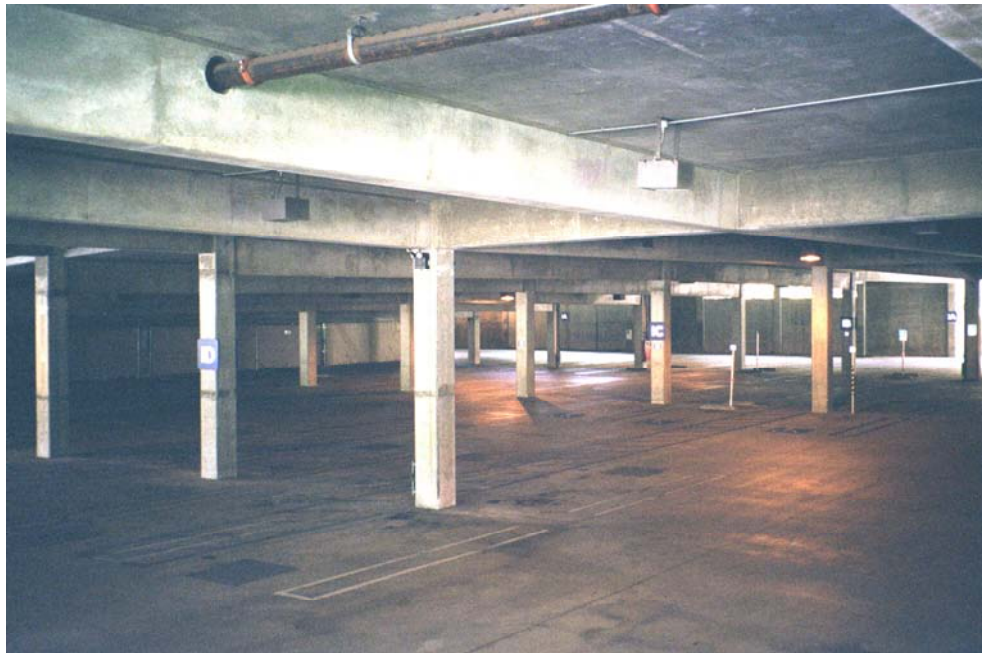
Figure 3-12 Interior view showing concrete columns and girders, which indicate a concrete moment frame (C1).

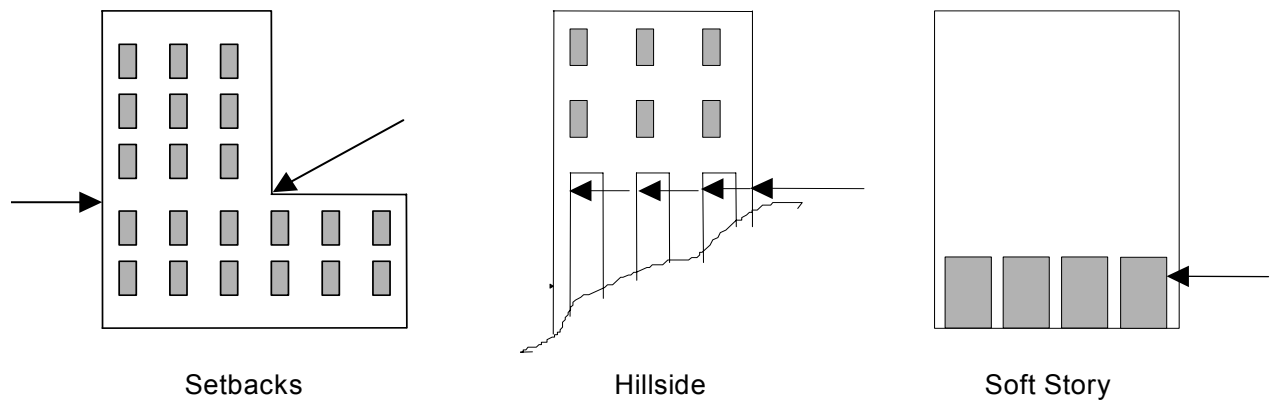
Figure 3-14 Elevation views showing vertical irregularities, with arrows indicating locations of particular concern.

If the building is on a steep hill so that over the up-slope dimension of the building the hill rises at least one story height, a problem may exist because the horizontal stiffness along the lower side may be different from the uphill side. In addition, in the up-slope direction, the stiff short columns attract the seismic shear forces and may fail. In this case the performance modifier is applicable. See Figure 3-14 for an example.

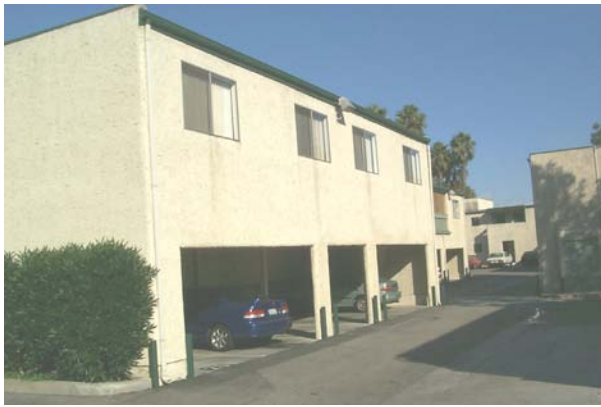
Figure 3-16 Example of soft story conditions, where parking requirements result in large weak openings.

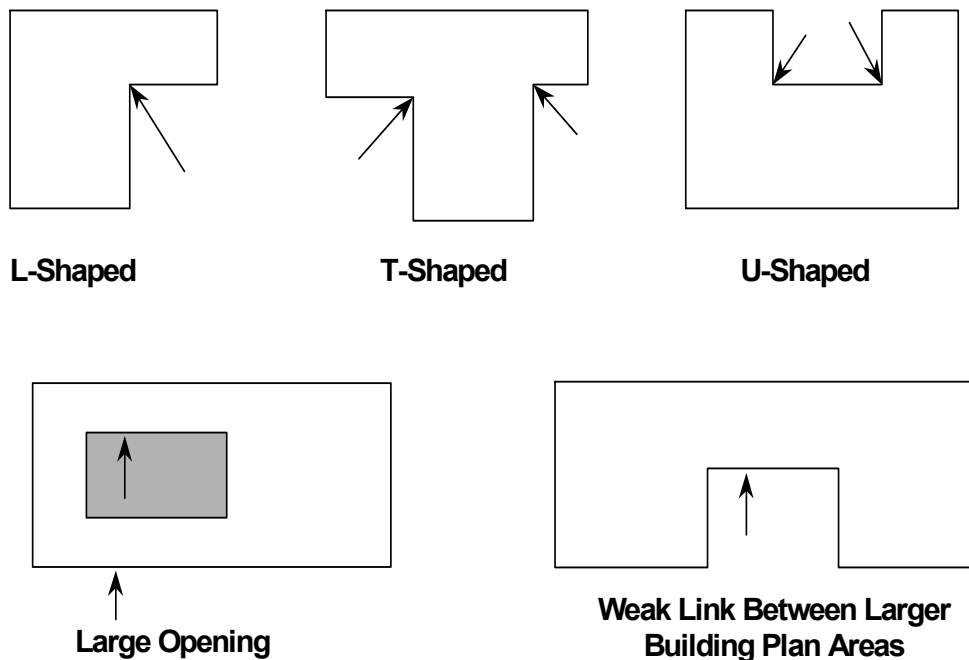
Figure 3-17 Plan views of various building configurations showing plan irregularities; arrows indicate possible areas of damage.

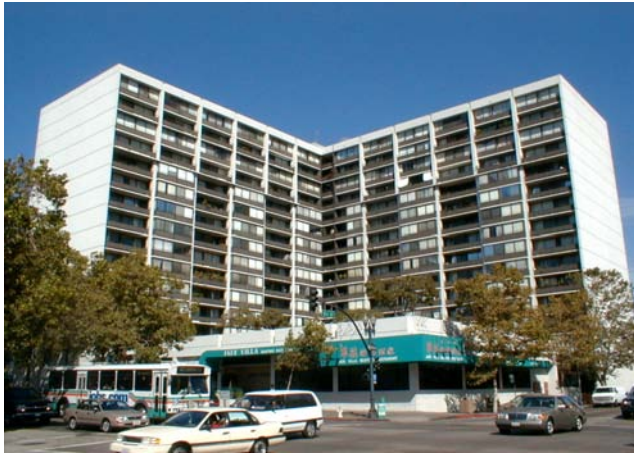
Figure 3-18 Example of a building, with a plan irregularity, with two wings meeting at right angles.

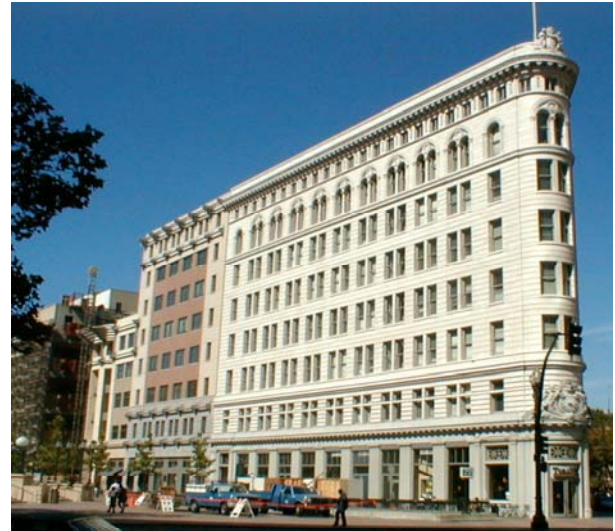
Figure 3-19 Example of a building, triangular in plan, subject to torsion.

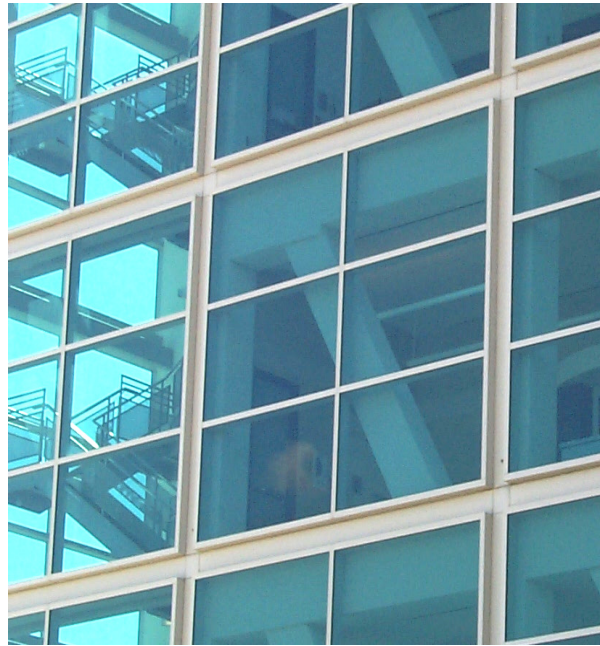
Figure 5-6 Close-up view of 3703 Roxbury Street exterior showing perimeter braced steel framing.

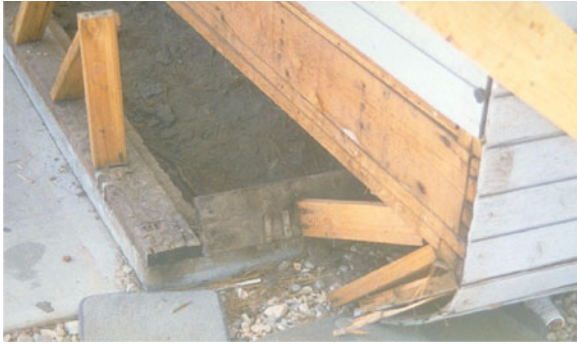
Figure E-8 Failed cripple stud wall, 1992 Big Bear earthquake.

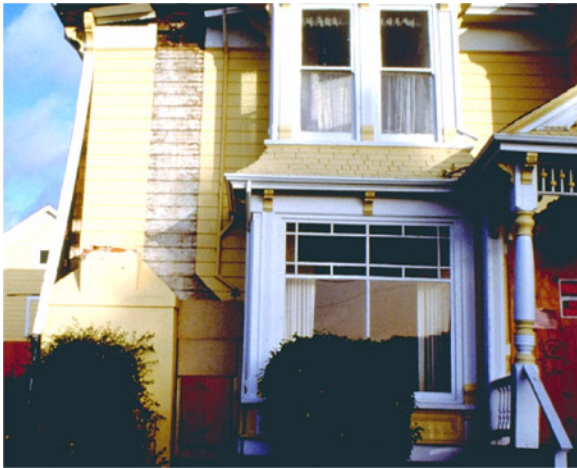
Figure E-9 Failure of post and pier foundation, Humboldt County.

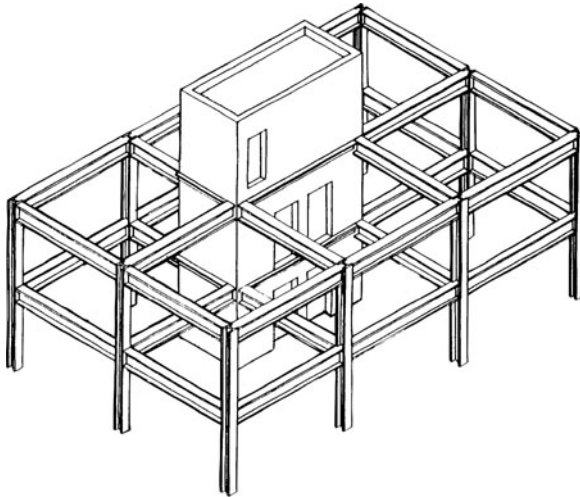
Figure E-20 Drawing of steel frame with interior concrete shear-walls.

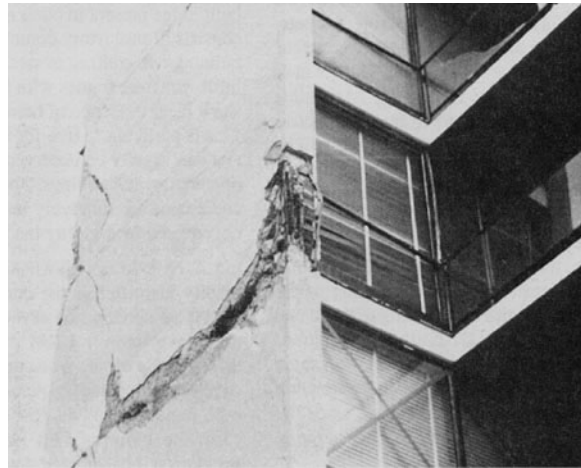
Figure E-22 Close-up of exterior shear wall damage during a major earthquake.

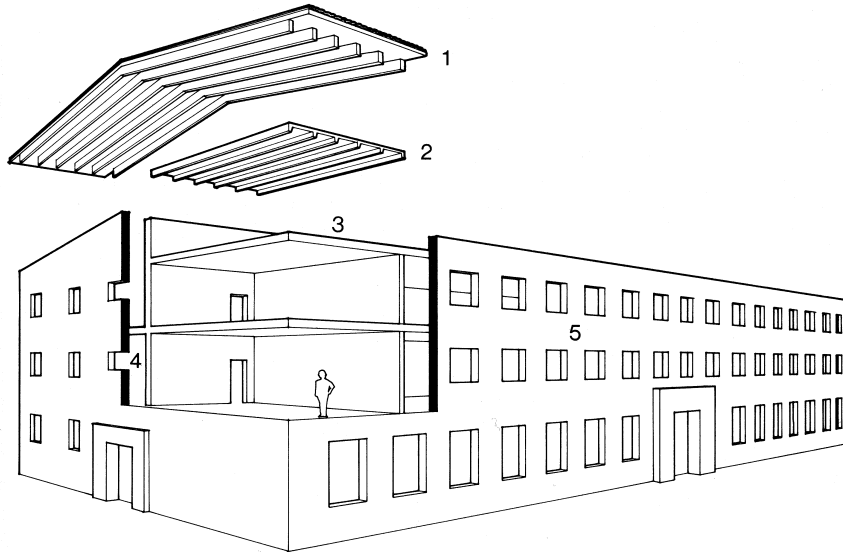
Figure E-30 Drawing of concrete shear-wall building.

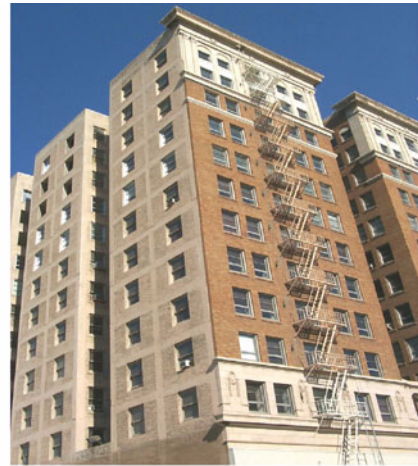
Figure E-34 Blow-up (lower photo) of distant view of C3 building (upper photo) showing concrete frame with URM infill (left wall), and face brick (right wall).

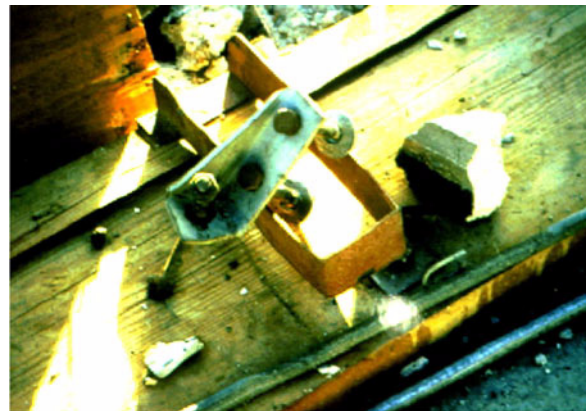
Figure E-38 Tilt-up construction anchorage failure.

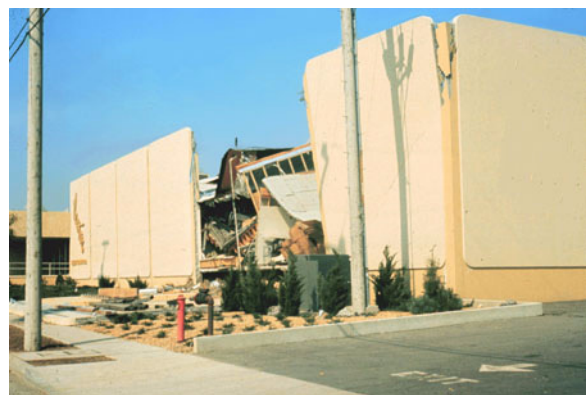
Figure E-39 Result of failure of the roof beam anchorage to the wall in tilt-up building.

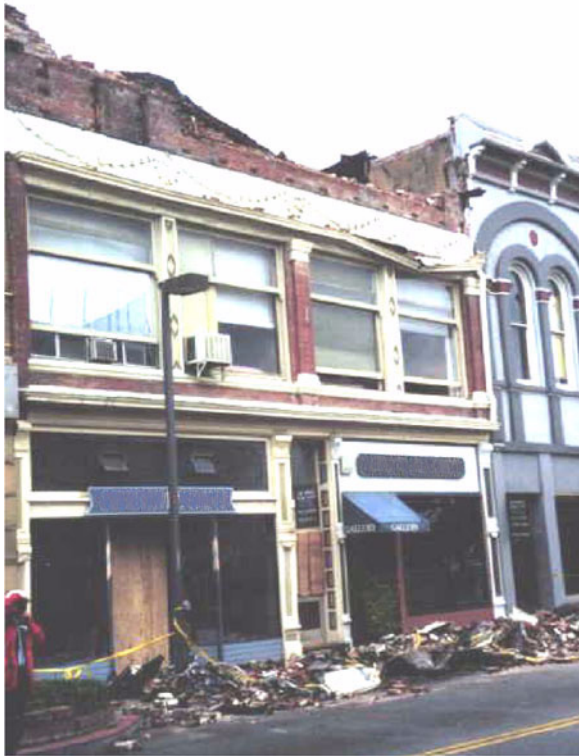
Figure E-53 Parapet failure leaving an uneven roof line, due to inadequate anchorage, 1989 Loma Prieta earthquake.

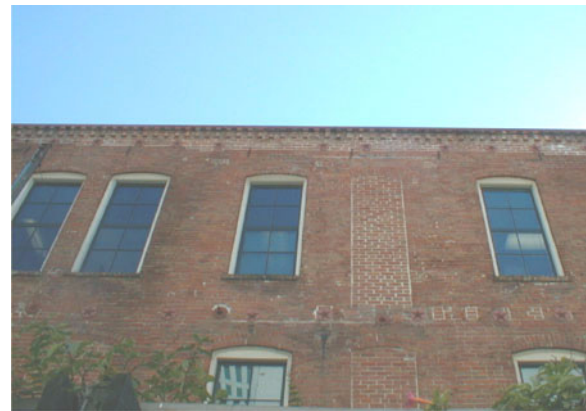
Figure E-55 Upper: Two existing anchors above three new wall anchors at floor line using decorative washer plates. Lower: Rehabilitation techniques include closely spaced anchors at floor and roof levels.
