**Figure 2.11.**  
**Conceptual solutions for structural reinforcement**

## Coordinating the retrofitting process

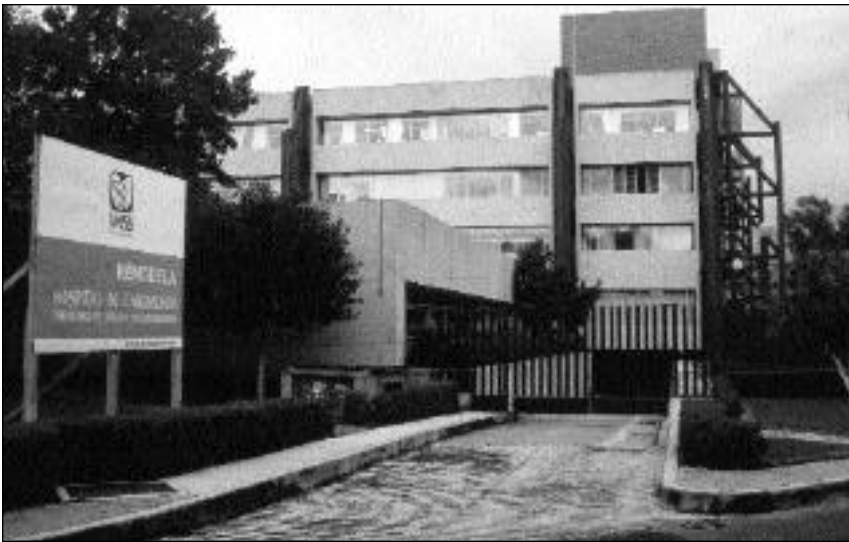
Photograph 12. The Cardiology Hospital of the Mexican Social Security Institute was retrofitted using buttresses following the 1985 Mexico City earthquake.

Unlike exterior building walls, buttresses are placed perpendicular to the face of the building. Aside from providing rigidity, they are useful in preventing tall, narrow buildings from overturning. The Cardiology Hospital of the Mexican Social Security Institute (IMMS) uses this type of reinforcement (see pho-

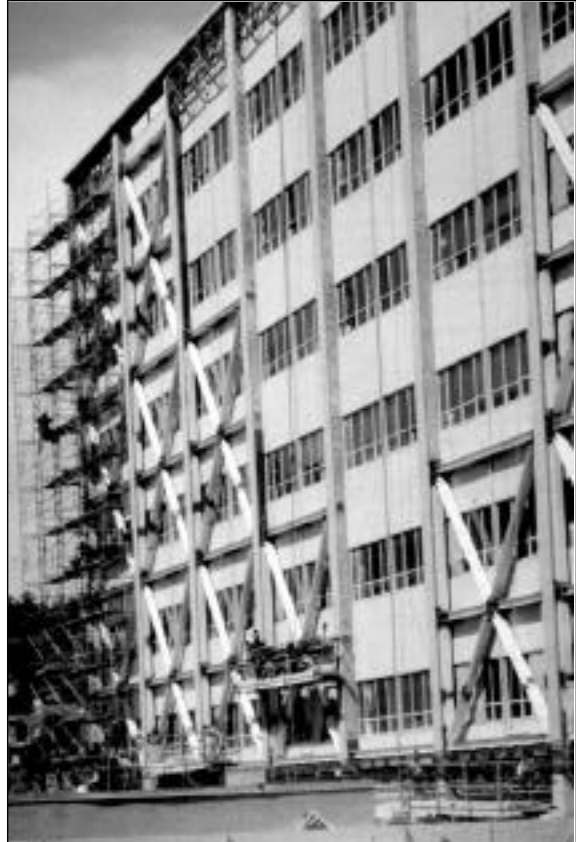
Photograph 13. Reinforcement with diagonals.

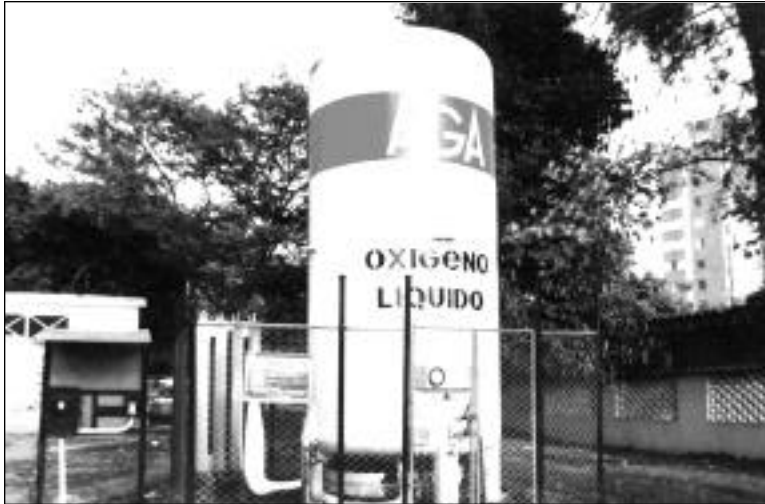
Photograph 15. Side view of the liquid oxygen tank.

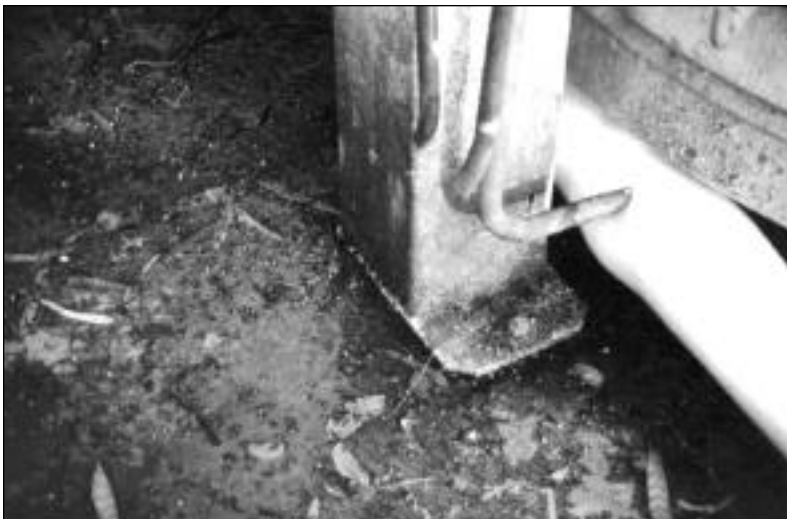
Photograph 16. Detail of support connections for liquid oxygen tank.

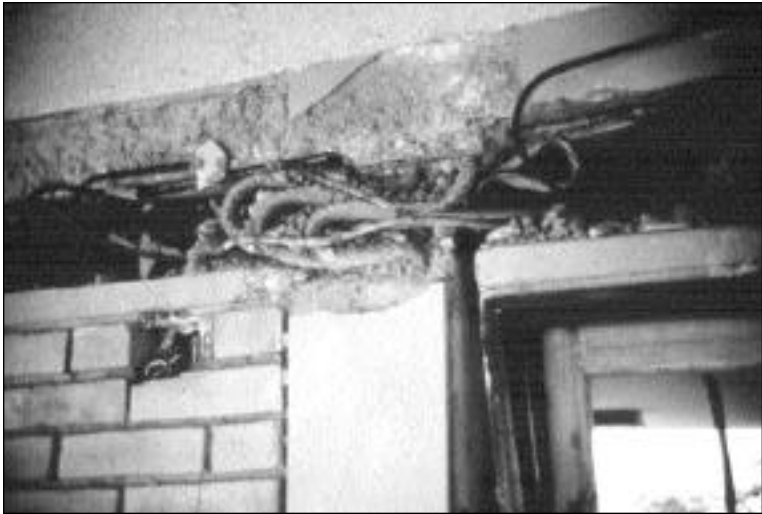
Photograph 18. Short-column effect

Another architectural problem that has an impact on the structure is the "short column effect" (see photograph 18). Sometimes, particularly during the remodeling of a building, openings in the structure are closed with masonry infill to a certain level, leaving space for windows in the upper part. This confines the lower part of the columns and essentially shortens their effective length. It is known that such "short columns" fail in the case of earthquakes.

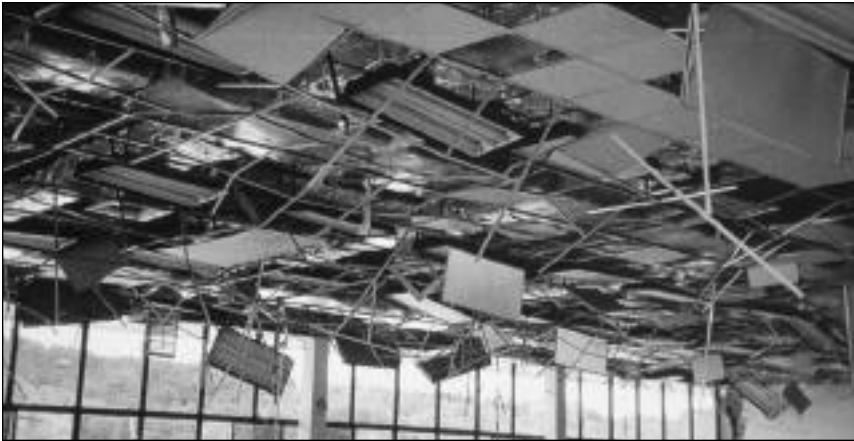
Photograph 19. Damage to ceilings

A certain range of deformations in the aluminum plate can cause the massive collapse of ceiling panels (see photograph 19), which poses the threat of possible injuries to the occupants and can cause damage to equipment and block exit routes.

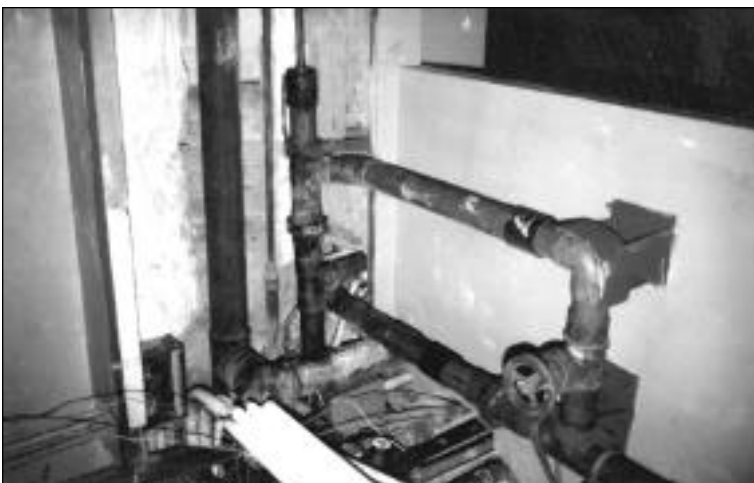
Photograph 22. Rigid piping

**Flexible couplings** sometimes are used between buildings and outside tanks, between separate parts of the same building, and between buildings (see photographs 21 and 22). They are used because the separate objects each move independently in response to an earthquake: some move quickly, others slowly. If there is a tank outside the building with a rigid connection pipe that joins them together, the tank will vibrate at frequencies, directions and amplitudes that are different to those of the building, causing the pipe to break. A flexible pipe between the two would prevent ruptures of this kind (see figure 3.4) .

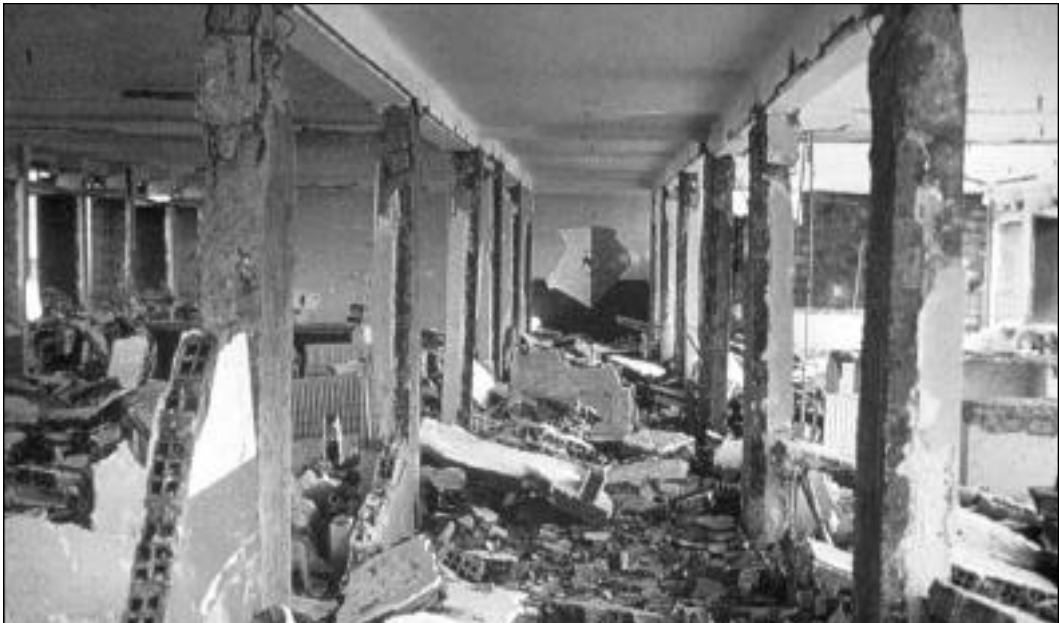
Photograph 24. Walls destroyed due to flexibility of the structure

The decision to isolate masonry elements must be done with care. They must be suitably anchored to compensate for their independence and to prevent collapse (see photograph 24). In general, the structure's masonry should be isolated in the following cases:

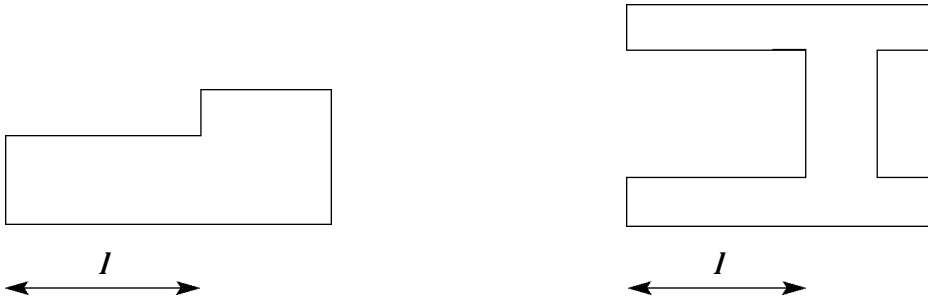
In floor plans of type L, T, U and others, the longer side is considered  $2 \times l$ , with  $l$  shown in the figure below.
